4. Fire/Explosion

TOSHA Citation(s) as Originally Issued

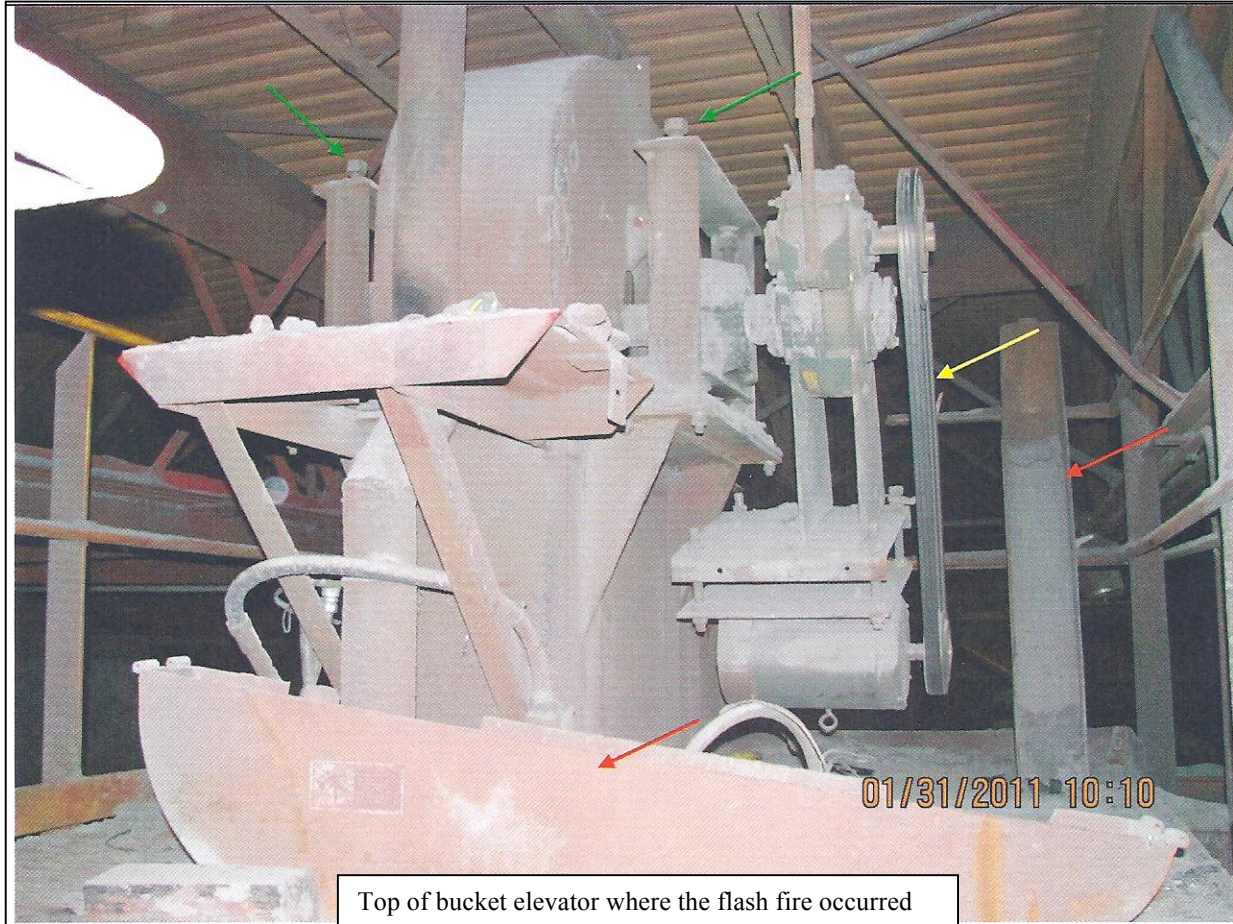
Two employees, a 42-year-old and a 32-year-old, received third degree burns over most of their bodies after an explosion in their workplace. Both employees subsequently died from their injuries. The company manufactures iron powder from scrap metal through a multi-step process involving molten metal, high-pressure cold water, high-temperature furnaces, annealing, mixing with carbon, and other procedures. Once the process is complete, the final product is transported through a series of bucket-elevator and screw conveyors to the storage area and placed into shipping containers. Two maintenance personnel went to the top of a bucket-elevator conveyor to determine why it had shut down. One of the maintenance employees radioed the elevator operator to try and restart the machine. When the operator did so, the surrounding suspended iron dust ignited and created a flash fire, burning both maintenance workers. Large accumulations, up to 4 inches in some locations, of combustible iron dust was found on the machine itself, as well as on the surrounding rafters, trusses, walking surfaces and guardrails.

Top of bucket elevator where the flash fire occurred
