## **Caught in auger – Inspection #1040935**

Caught in auger – Inspection #1040935

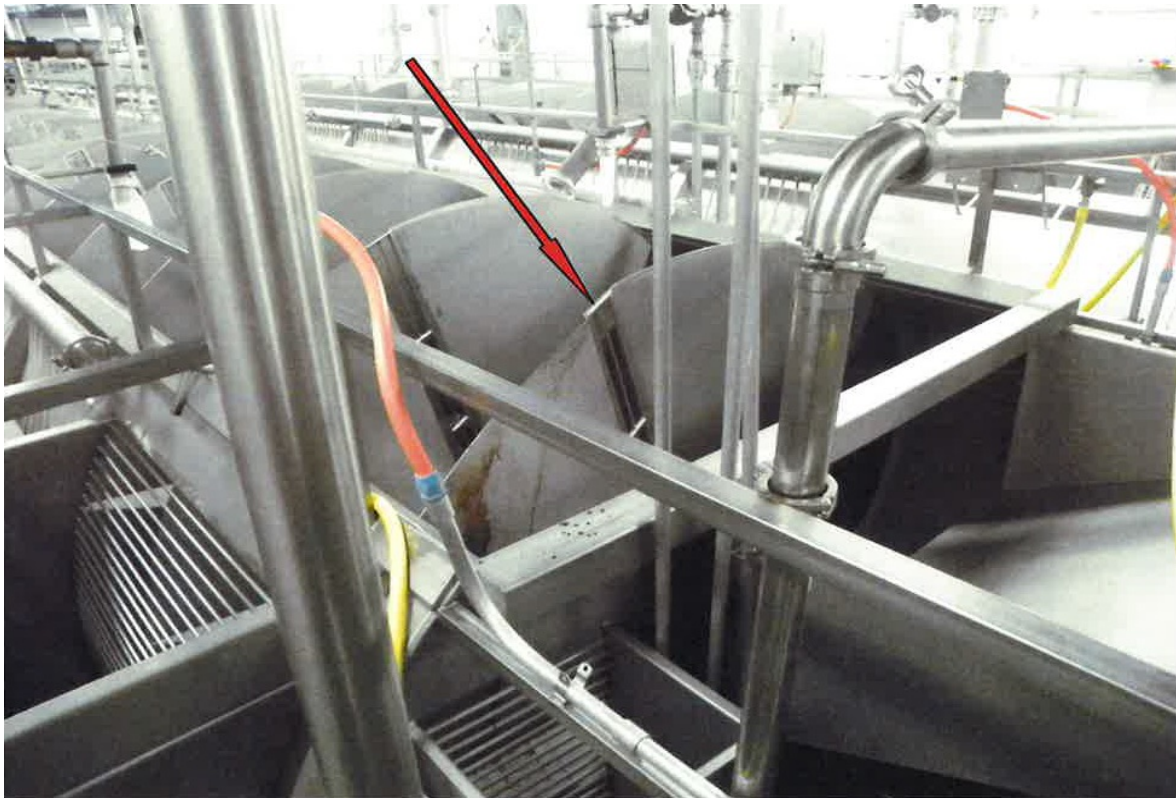
A **38 year old male** was fatality injured when his arm, and upper body was pulled into an operating auger as he leaned over the catwalk railing to clean, and sanitize a poultry processing chiller tank. The victim, along with other employees, were cleaning, and sanitizing the reverse flow, cold water chillers in a poultry processing plant. The victim was told to stay on the central catwalk, and left alone to spray down the tank interior of Chiller #2 with hot water, and sanitizing solution while the auger was in operation. During the cleaning process, a nearby employee heard a noise, and saw the victim's legs extending from beneath the guard rail positioned approximately 15 inches above the top of the tank. The emergency pull cable was activated immediately. The victim was fatality injured by blunt force trauma to the body. There were no witnesses to the actual incident, but it remains a possibility the employee moved from the central catwalk, to the outer catwalk of Chiller #2 reaching in with his arm, and body to clean the interior of the tank, and was caught by the auger blade, pulling the employee into the tank from the catwalk. This was his sixth day of employment.

allowed to continue to operate while employees sprayed down the interior of the tank. Part of this process required that hot water and detergent be sprayed on the surfaces of the tank interior to aid in cleaning. The employee spraying the tank interior worked from the catwalk located between the two chillers. The process in place at the time of the accident (with the augers running) exposed employees to coming in contact with the auger blades (containing vents for water flow) and to pinch points hazards where the auger blades run in close proximity to the tank wall. The serial number for the equipment was 5467-0313.

Photo 1 of 1 – Photograph showing the auger in chiller #2
