A 28 year old male employee was fatally injured when he was crushed by soil during a trench collapse. On the day of the incident the victim was laying sections of 4 inch PVC heavy wall sewer pipe to replace the current sewer pipe in a trench measuring approximately 100 feet long, 3 foot wide, and 7 feet deep. At the end of the day, the victim was in the trench picking up his tools and equipment, handing them up to another employee that was standing on the edge of the trench. Suddenly, a large section of the west trench wall collapsed, trapping the victim chest deep, against the opposite side of the trench. A protective system was not in place for the victim at the time of the accident, nor during the entire project. The site competent person misclassified the soil as type "A". The company owned a trench box, but it was not used at this site.

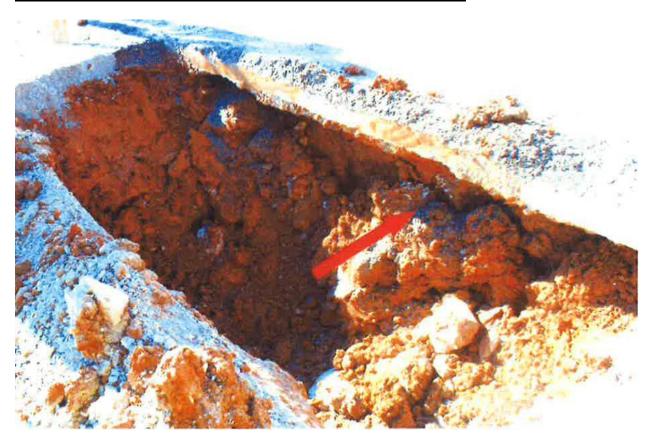
29 CFR 1926.652(a)(1)	Each employee in an excavation was not protected from cave-ins by an
	adequate protective system designed in accordance with 29 CFR
	1926.652(c). In that an employee was working in an excavation at a
	depth of approximately 7 feet 6 inches with vertical walls with no
	protective system in place.

Photo 1 of 1 – Approximate location of the west trench wall that collapsed trapping the victim against the opposite side. The trench was completely back filled when TOSHA arrived for the investigation. TOSHA requested the trench be dug back out to show the condition of it at the time of the incident.
