## **27 Struck by forklift – Inspection #1185791**

A **58 year old male** employee was fatally injured when he was struck by a 14,000 pound forklift. On the day of the incident the victim, a boiler tech, was standing in the roadway near the railroad tracks directing a semi-truck driver picking up a load of sawdust at the manufacturing site. At the same time, a Taylor brand #21, model #TE-360L forklift was carrying two bundles of lumber from the stacker to the yard area located near the railroad tracks. The operator had to drive with the load trailing because the two bundles obstructed his view traveling forward. He stated that he traveled backwards steering with his left hand and looked over his right shoulder. The forklift operator turned at the intersection to go over the railroad tracks and towards the yard area when he felt a bump. During the investigation it was determined that the back-up beeper and horn were inoperable and both side mirrors were missing on the Taylor forklift. Daily forklift inspections occur but the inspection for the Taylor forklift involved in this incident could not be located.

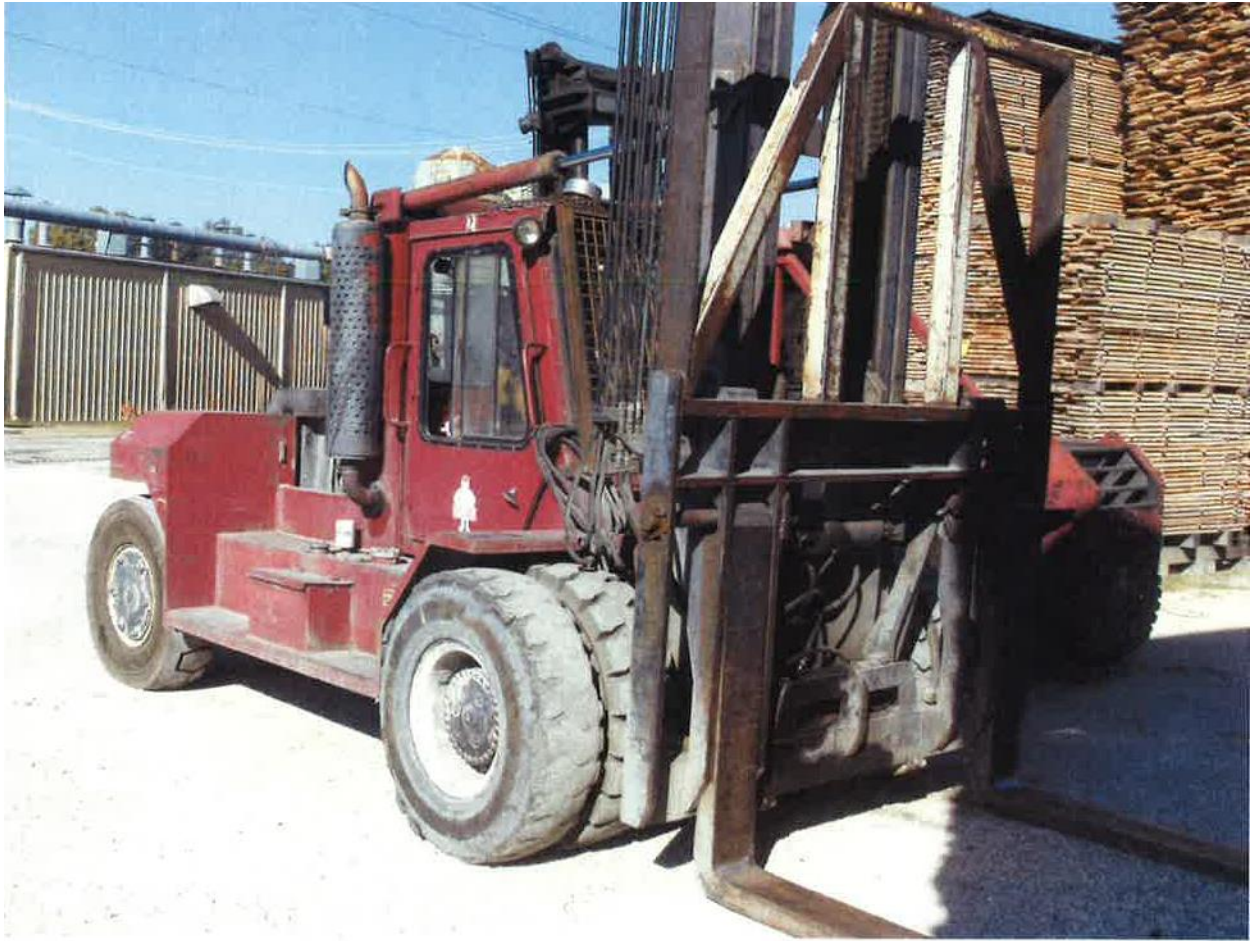
29 CFR 1910.178(p)1)	Powered industrial truck(s) with defect(s) or in any way unsafe had not been withdrawn from service until restored to safe operating conditions(s). IN that Taylor forklift, Model #TE-360L, continue to be operated with an inoperable horn, inoperable back-up beeper and both side mirrors removed.
----------------------	--

Photo 1 of 1 – Forklift involved in the incident did not have an operable horn or an operable backup beeper. Manufacture stated the forklift was also equipped with two side mounted cab mirrors. These mirrors were not on the forklift at the time of the accident.
