31 Crushed by counterweight on lift table elevator system – Inspection #1192147

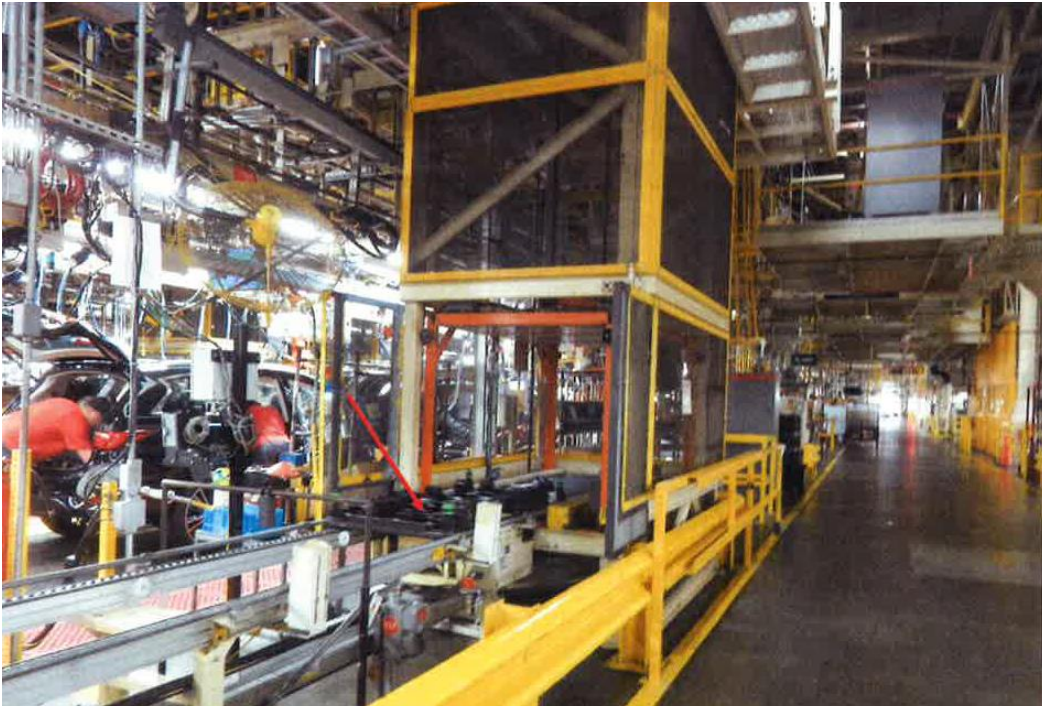
Photo 1 of 2 – Empty car seat pallet (red arrow) as it is entering the DL85 elevator to be transported up to the return conveyor.

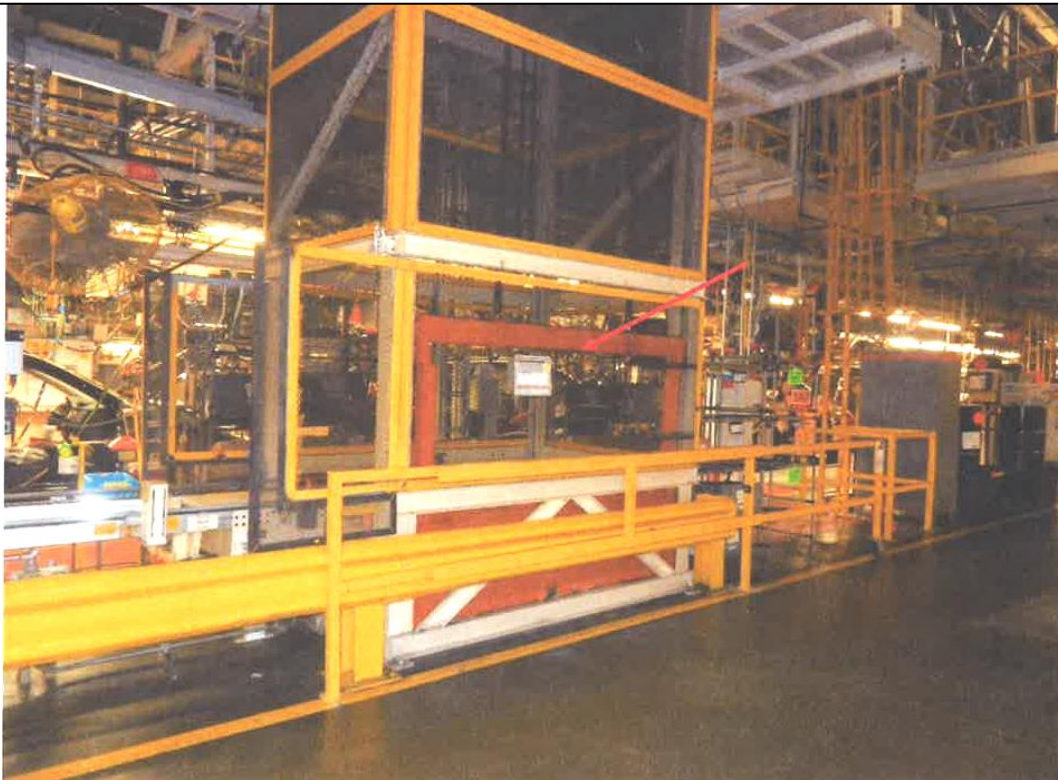
A **46 year old male** employee was fatally injured when he was crushed by the counterweight on a lift table elevator system. On the day of the incident, the victim, a maintenance technician, was replacing the drive motor on the conveyor system lift table, inside the DL85 drop loader or elevator. The elevator is designed to remove empty automobile seat pallets from the conveyor system, and lift them 15 feet above to another conveyor system, designed to transfer the pallets for vendor return. While testing the drive motor on the conveyor rollers, the victim leaned into an opening within the metal mesh containment to look under the ascending lift table during activation, and was struck by the descending elevator counter balance weight weighing approximately 1,275 lbs. The guard for the opening had been removed for the repair and was not replaced before the victim activated the conveyor system lift table and elevator.

Photo 2 of 2 – Counterweight (red arrow) descended in the DL85 elevator after an empty car seat pallet has been transported up to the return conveyor.
