## 29 Electrocutation – Inspection #1263792

A **30 year old male** employee was fatally injured when he was electrocuted while removing a street light pole as part of a roadway expansion project. The victim was working to remove an aluminum street light pole when the pole contacted a nearby energized 7,620 volt single phase overhead power line. The street light poles had been de-energized by the local utility board prior to the beginning of the removal project. The employees were utilizing a derrick/digger to lift the pole. Four poles had been removed and employees were in the process of removing the fifth when the incident occurred. Once the pole had been rigged to the derrick, the base of the pole was unfastened and pole was lifted to be placed on a trailer. The victim was designated as the person to guide the pole from the ground and assist in controlling the pole by hand once lifted off its base. The derrick operator reported that the pole moved in the direction of the nearby live powerlines. The pole came into contact with the live power lines while the victim was touching the base of the pole which caused the victim to be electrocuted.

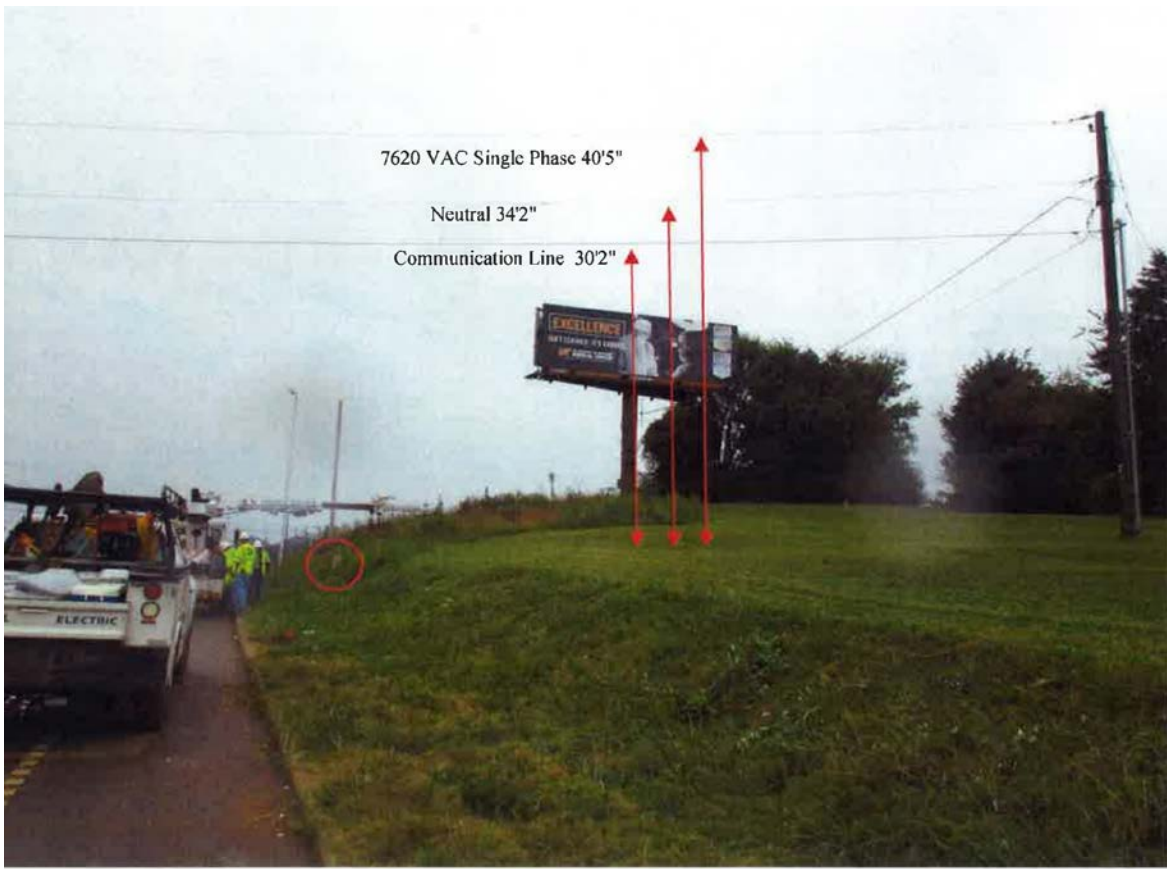
Photo 1 of 1 – Photo shows an overall view of the incident scene. The overhead powerlines are identified with the red arrows. The red circle indicates the original location of the street light pole.
