#### 30 Fall from I-beam – Inspection #1267346

A 27 year old male employee was fatally injured when he fell a distance of 15 feet 3 inches from an I-beam of an engineered steel building being constructed. The company had been contacted to install a new steel building. On the morning of the incident, three employees began installing the purlins to the rafters of the building and they installed a new plate on the jack beam in the middle of the building. The employees took a lunch break around 11:30am. After their lunch break, the employees went back to installing the purlins. The investigation revealed that the victim and another employee climbed onto the rafters using a step ladder to continue installing purlins. Both the employees got into position and sat down on I-beams. Next, they stood the purlin upright and aligned the bolt holes with a spud wrench. As the first bolt and nut was being installed, the purlin shook. The employee noticed that the victim was slumped over and began to fall toward the ground. Since the beginning of the project, 45 purlins had been installed by the employees. The victim fell from the rafter while in process of installing the 46<sup>th</sup> purlin. T

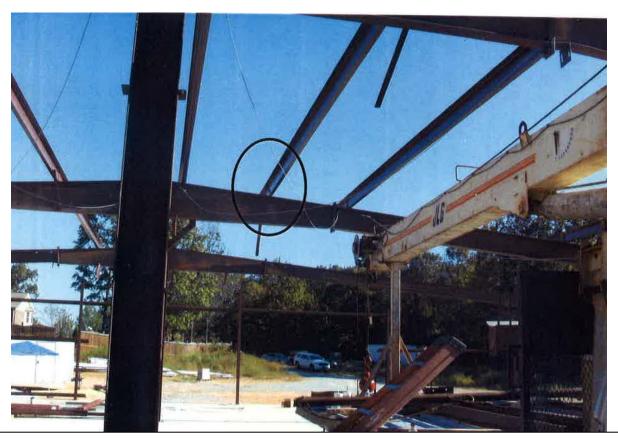
29 CFR 1926.760(a)(1)	Each employee engaged in steel erection activity that is on a walking working surface with an unprotected side or edge more than 15 feet above a lower level was not protected from fall hazards by guardrail systems, safety nets systems, personal fall arrest systems, positioning device systems, or fall restraint systems.
	In that employees erecting the engineered steel building were not protected from falling when working above 15 feet. An employee was fatally injured when he fell approximately 15 feet 3 inches to the concrete floor below.

Photo 1 of 1 – Area circled is where the victim was working when he fell.

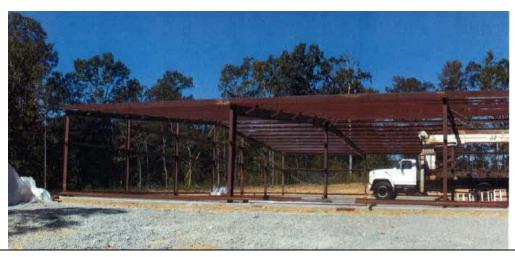
Photo 1 of 1 – Photo shows a view of the steel building where the employees were working the incident occurred.
