3 Fall through Skylight – Inspection #1204459

A **68 year old male** employee was fatally injured when he fell through a roof skylight to the ground below. On the day of the incident, the victim was assisting in the repair of a leaky metal roof at the building where he worked as a printing technician. The fiberglass skylights on the roof measured approximately 2 feet wide by 8 feet long, and were flush with the metal roof. As the victim and co-workers checked roofing screws for leaks, the victim walked across the roof to get a caulking gun, and inadvertently stepped onto one of the fiberglass skylights falling 14 feet to the concrete floor. It was determined during the inspection that fall protection or prevention devices were not used to protect employees from a fall.

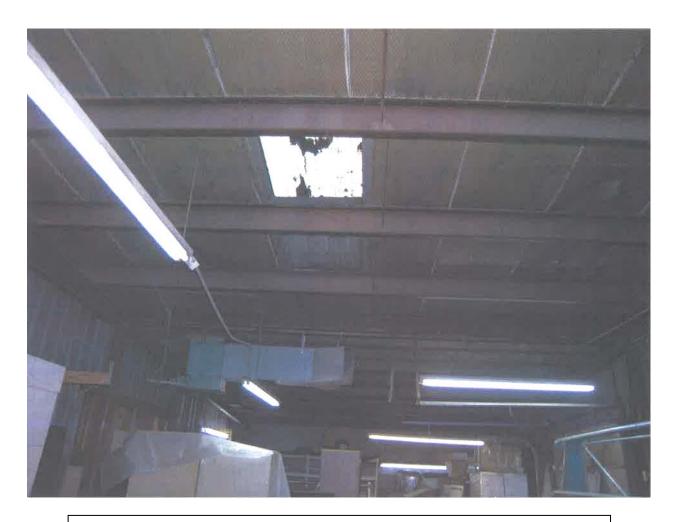
29 CFR 1910.23(a)(4)	Every skylight floor opening and hole was not guarded by a standard skylight screen or a fixed standard railing on all exposed sides.
	In that the employer did not have a standard skylight screen or a fixed standard railing guarding the northwest skylight in the Carpet Room's metal roof, exposing three employees to a fall hazard of approximately 14 feet to the concrete floor below.

Photo 1 of 1 – Fiberglass skylight panel and the roofing tin cover.
