1 Struck by Truck Cab – Inspection #1288009

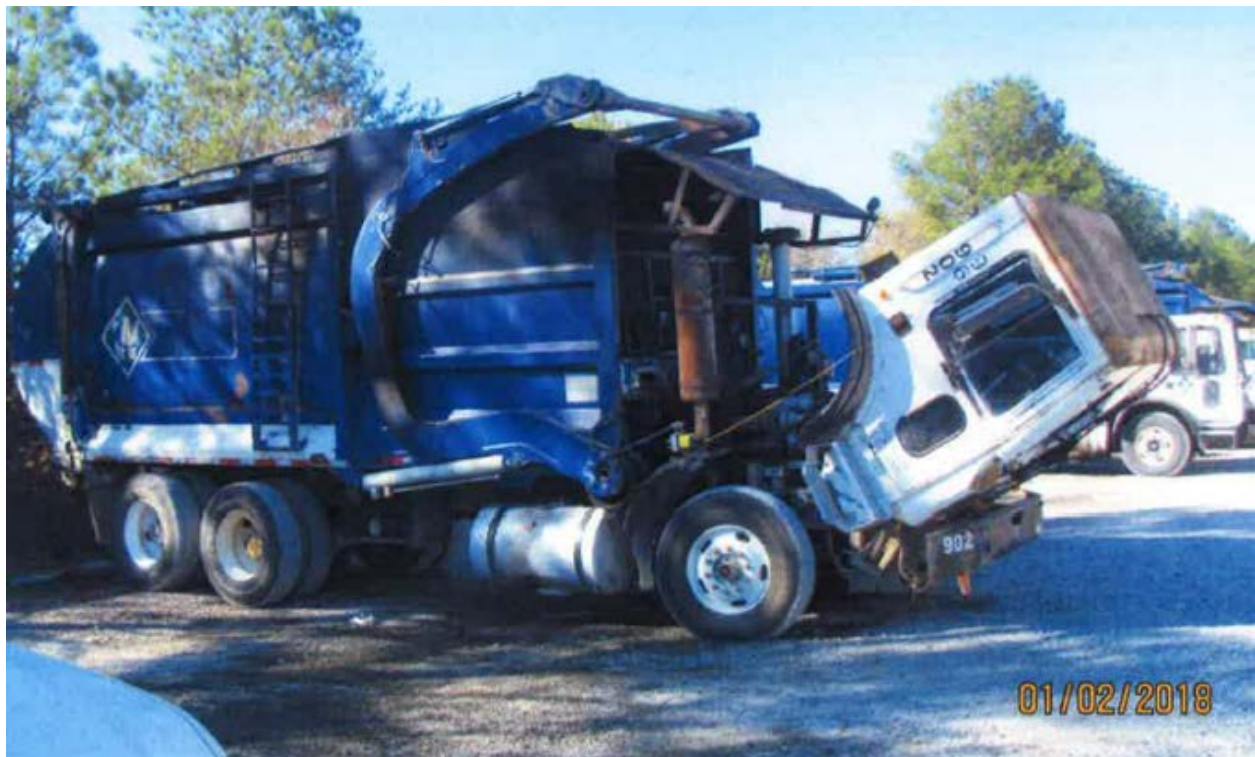
Photo 1 of 2 – Shows truck 902 with the cab in the fully tilted up position

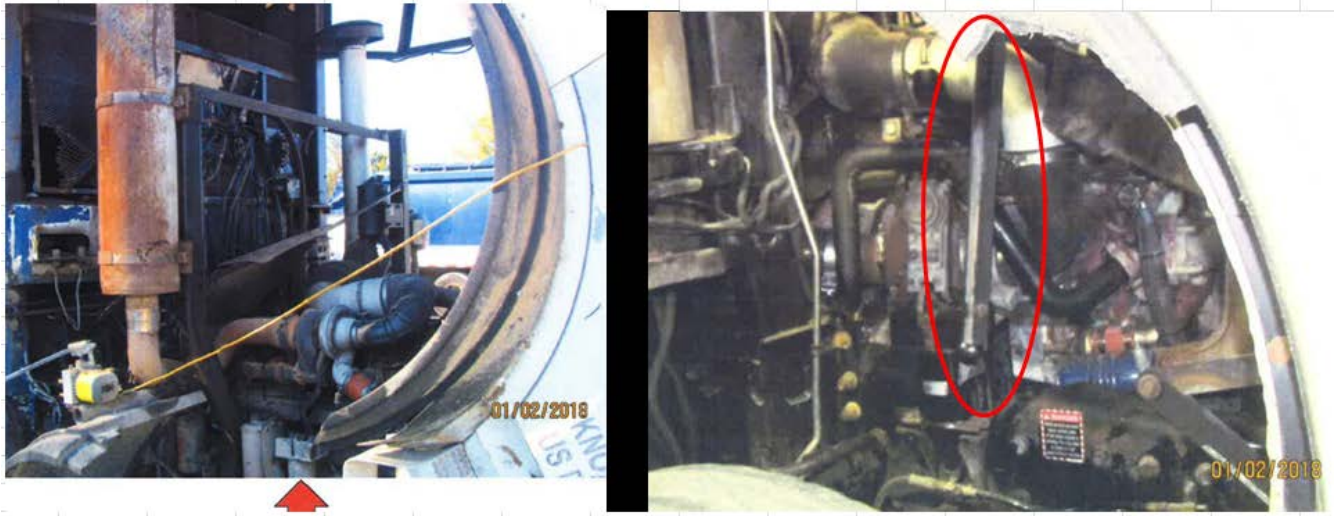
The investigation concluded that the employee was working under the cab of truck 902 with the cab partially lifted to the servicing position. The truck was not equipped with the proper prop stud and therefore the prop could not be engaged on the stud to prevent the cab from closing on the employee. The employee appeared to have been working in the area of the starter on the driver's side of the truck. An employee came outside of the shop and found the cab of the truck on top of the employee who was in the standing position between the inside of the wheel and the engine. The victim had been caught between the engine and the descending cab which resulted in the fatal injuries sustained by the employee.

<p>energy to the machine or equipment were not physically located and operated in such a manner as to isolate the machine or equipment from the energy source(s).</p> <p>In that the safety prop on the 902 truck was not used to isolate the unexpected release of gravity while an employee worked under the raised cab.</p>
--	---

Photo 2 of 2 – The left photo shows truck 902 with cab in the fully lifted up position. The cab latch with no safety prop stud attached is indicated by the red arrow. The right side photo shows the normal position of the safety prop indicated by the red circle. This photo is of another truck (903) that was located in the shop.
