RBJ Construction LLC

Fall from roof of fire hall

Inspection date: 6/13/19

10 Fall from elevation--Inspection #1408728 RBJ Construction

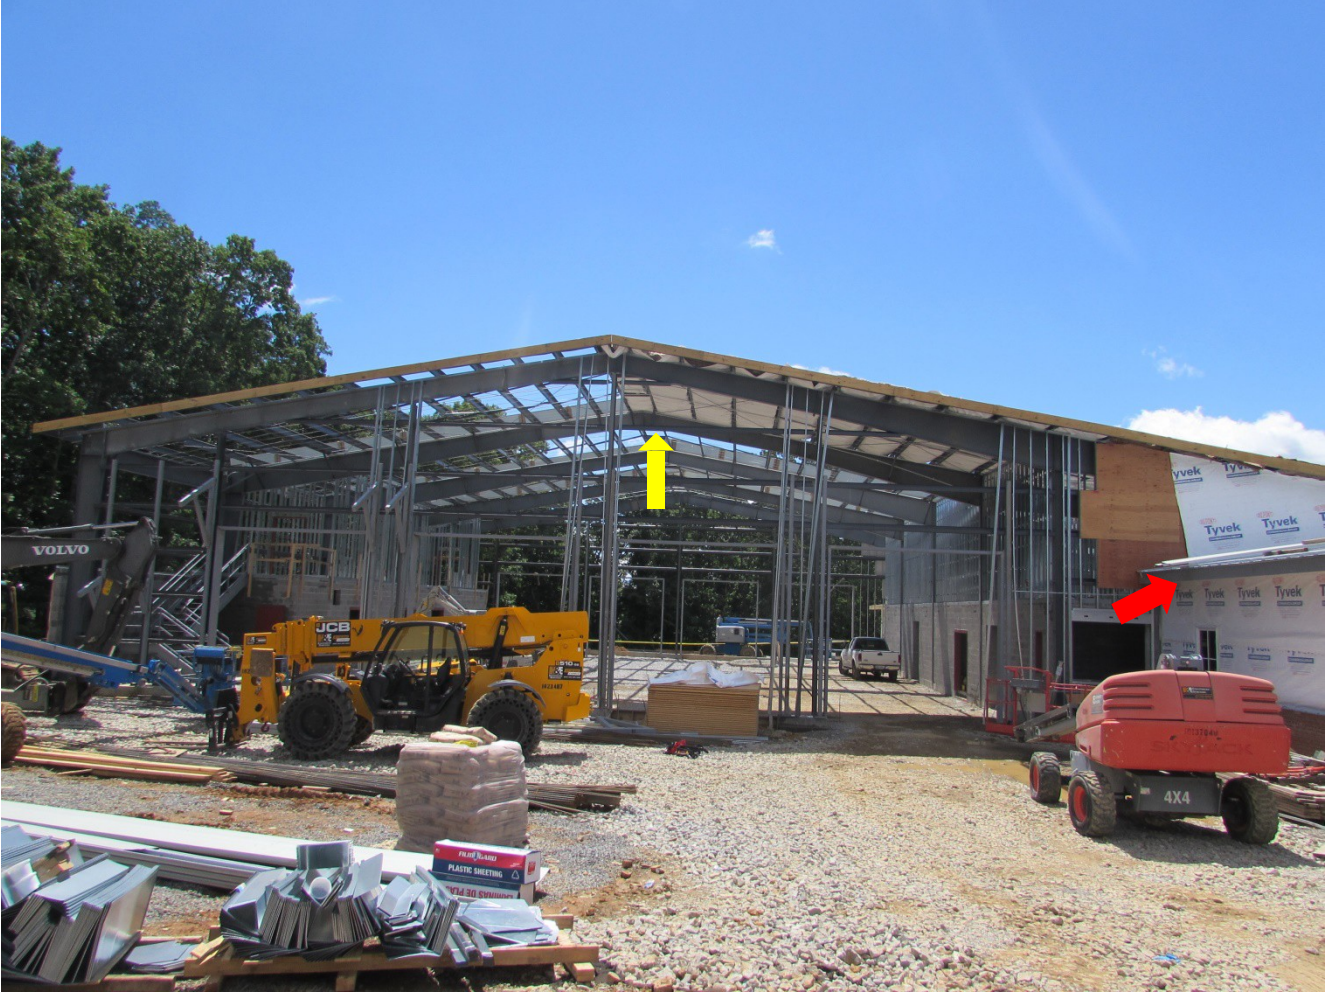
connected. The employee was walking on the purlins and he was not wearing fall protection. The purlins that the employee was walking on measured approximately 4 inches wide. While using a measuring tape, the victim was walking backwards and stepped on a bundle of roof sheeting. The string securing the sheeting did not prevent the bundle from shifting beneath the employee's weight. As the bundle slid down the roof, the employee fell backward, through the roofing purlins to the gravel ground below. The employee was positioned at the apex of the roof when he fell approximately 36 feet to the ground.

Photograph shows the east side of the construction site. The victim was working near the apex of the roof when he fell. The red arrow indicates the point of access to the roof. The yellow arrow indicates from where the victim fell.

29 CFR 1926.760(a)(1): Each employee engaged in a steel erection activity who is on a walking/working surface with an unprotected side or edge more than 15 feet (4.6 m) above a lower level was not protected from fall hazards by guardrail systems, safety net systems, personal fall arrest systems, positioning device systems, or fall restraint systems.

In that employees were exposed to an approximately 36 foot fall hazard while installing metal roofing an approximately 2:12 sloped roof due to the employer failed to provide or ensure the use of any form of fall protection resulting in a fatality.

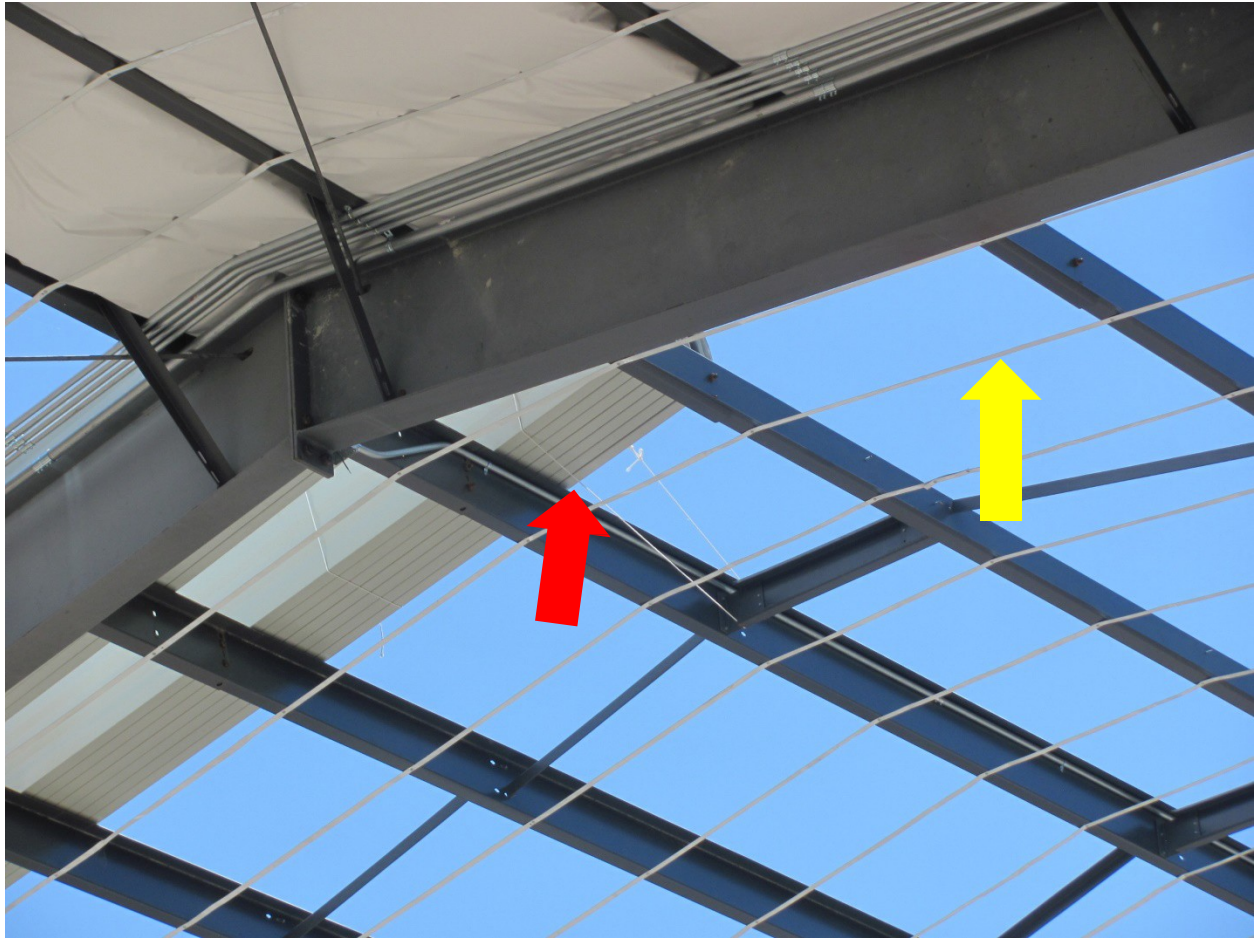
Photograph shows the area of the roof where the victim was working at the time of the fall.

The red arrow indicates a bundle of metal roofing sheets, secured with string, similar to when the incident occurred. The yellow arrow indicates the nylon banding installed to support the insulation and vapor barrier materials.
