A **32 year old male** employee was **crushed by/caught in** a rotating machine roller while attempting to package a mattress. The victim was in the process of operating the machine, rolling, and wrapping a twin sized mattress with cellophane to prepare it for packaging and shipping when he was caught by the roller.

### **Citation(s) as Originally Issued**

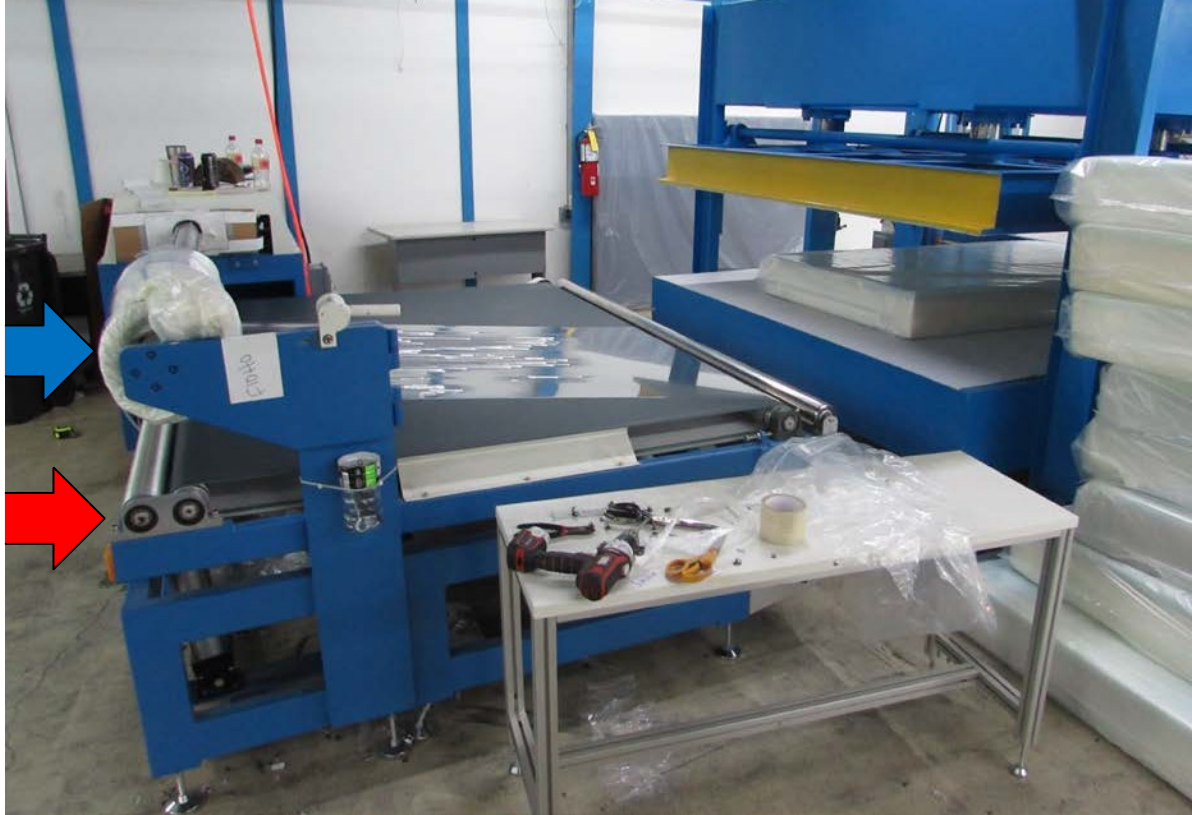
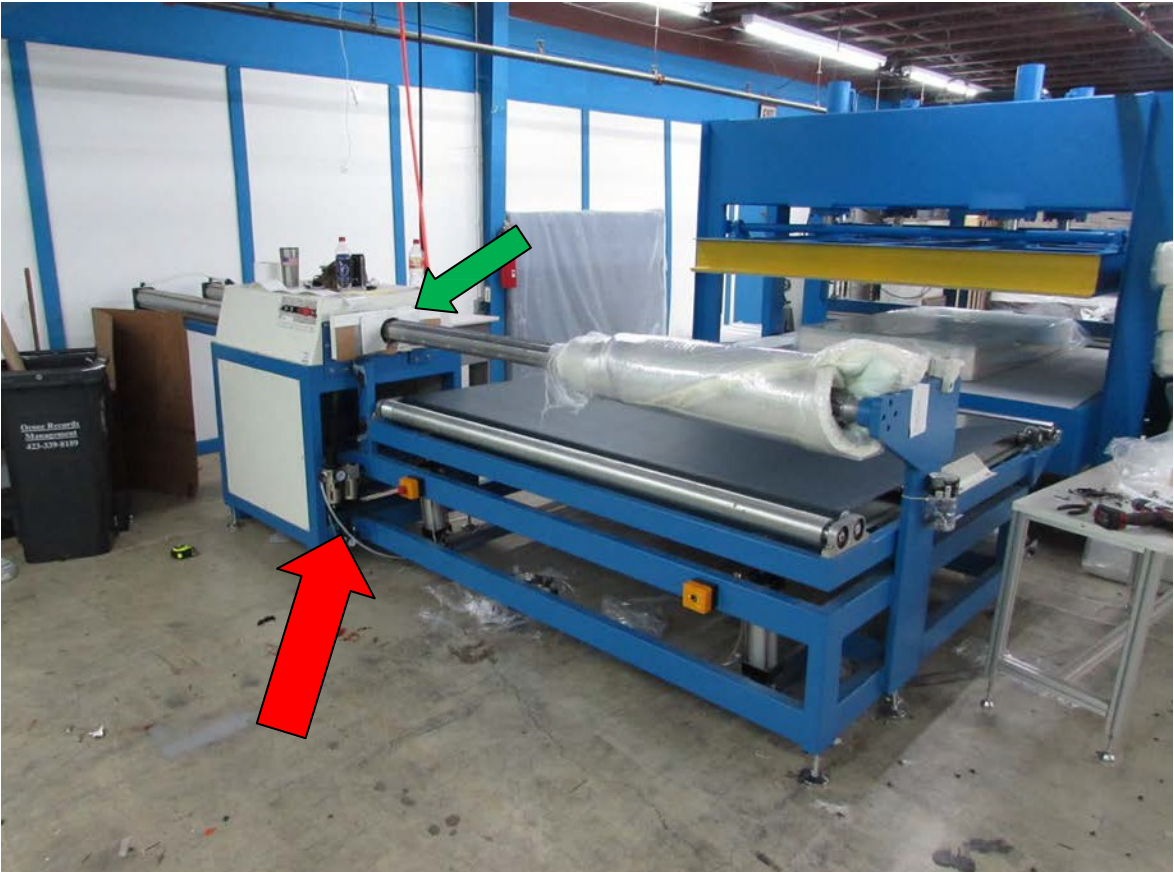
It was determined that the victim was working to roll and package a mattress on the roller machine. It is assumed that somehow his arm, sleeve, etc. was caught by the roller and he was thrown on to the conveyor table while it was moving and in the raised position. It appeared that the victim tried to hit the stop button and in the process dislodged the pneumatic line allowing the conveyor to lower creating an opening between the two rollers. Due to the movement of the conveyor belt, he was pushed between the upper and lower rollers of the machine sustaining fractures and compression injuries that resulted in the fatality.

In that there were four instances where there was no form of machine guarding to protect employees in the mattress compression and rolling process as follows:

- a) the press mechanism of the JK-C1 semi-auto mattress compression machine,
- b) the induction heat sealer adjacent to the JK-C1 semi-auto mattress compression machine,
- c) the ejection ram for the JK-R1 semi-auto mattress rolling machine, and
- d) the roller for the JK-R1 semi-auto mattress rolling machine that resulted in a fatality.

**29 CFR 1910.212(a)(1):** One or more methods of machine guarding was not provided to protect the operator and other employees in the machine area from hazards such as those created by point of operation, ingoing nip points, rotating parts, flying chips and sparks.
