A **27 year old male employee** was **struck** on the back of his left and right legs by the winching rope attached to a wood chipper as he and his supervisor were preparing to remove brush from a jobsite. Two days after the injury, he suffered from a blood clot which originated at the point of injury and traveled to his heart, resulting in death.

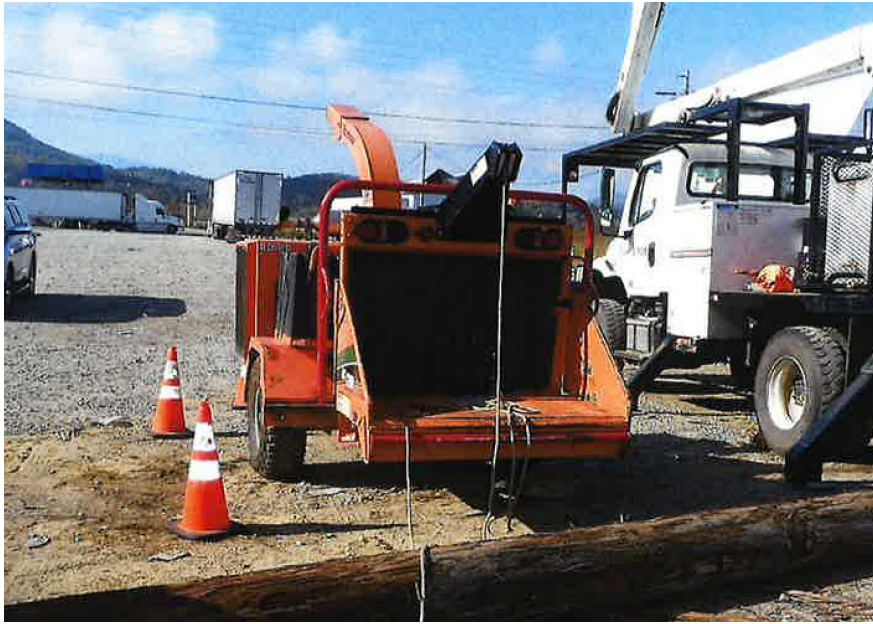
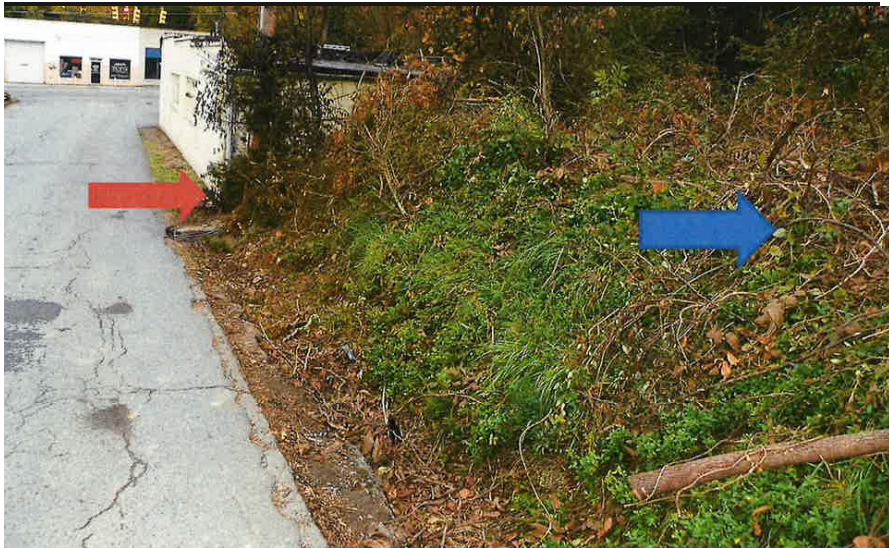
**Photograph shows:** red arrow where foreman was working and blue Arrow shows where victim should have been working.

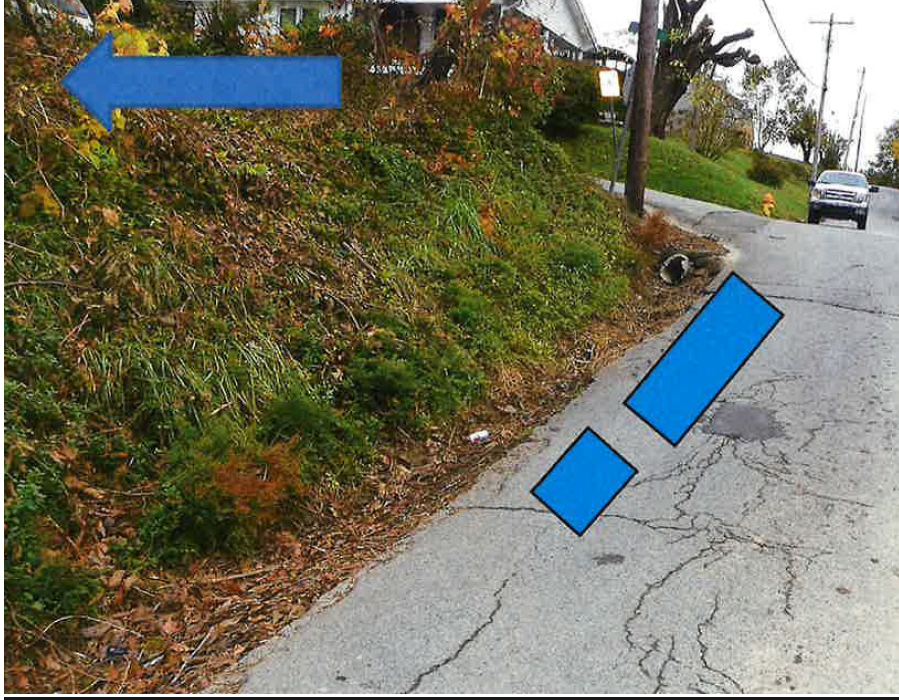
**Photograph shows:** rectangle boxes are where the chipper was located & arrow indicates where victim should have been working.
