A **25 year old male** employee was **struck by boom/delivery pipe of a concrete pumper truck** when the ground under the out-riggers on the passenger's side of truck collapsed causing the truck to shift.

44 Struck by concrete truck boom—Insp # 1506283 HC Concrete Construction

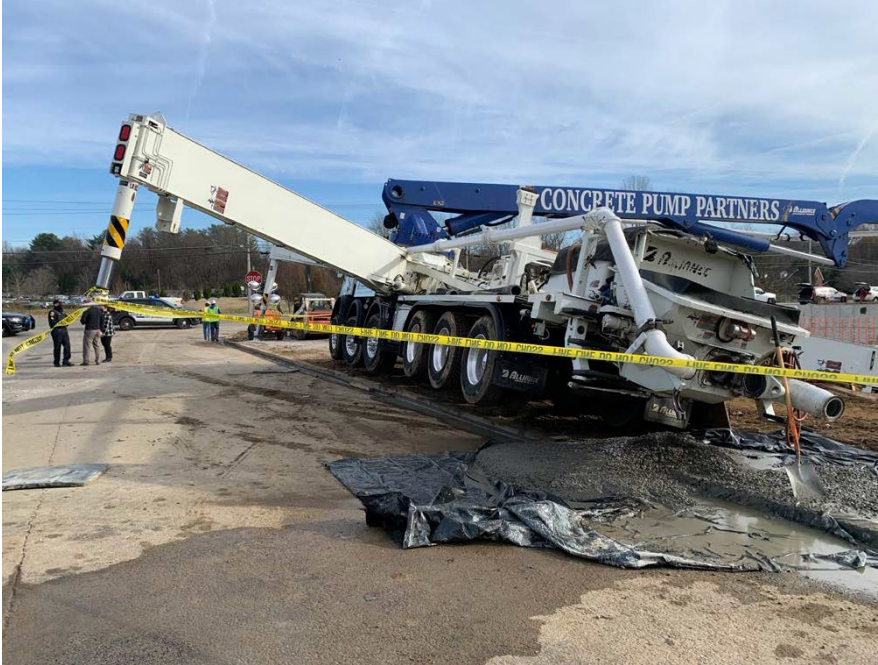
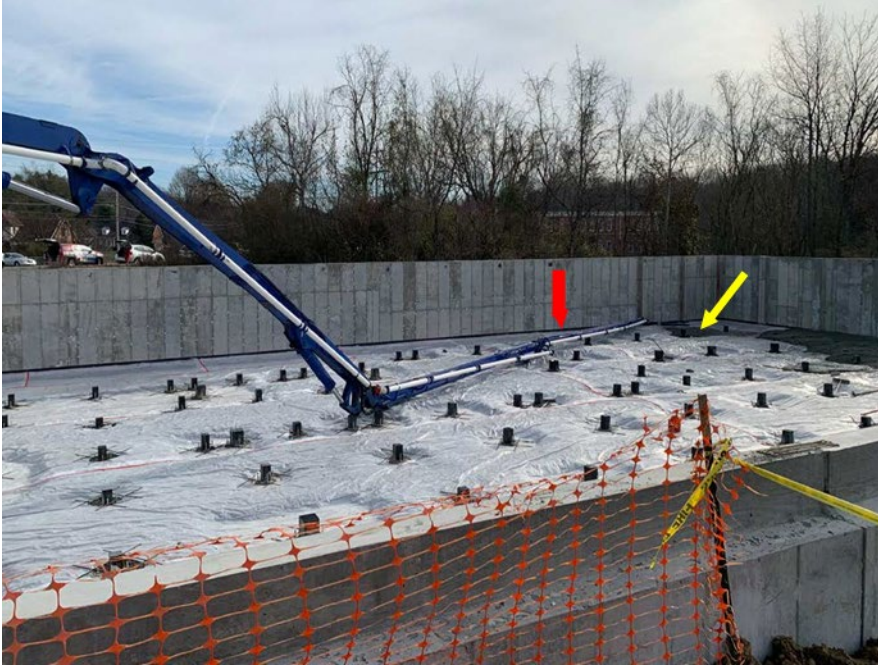
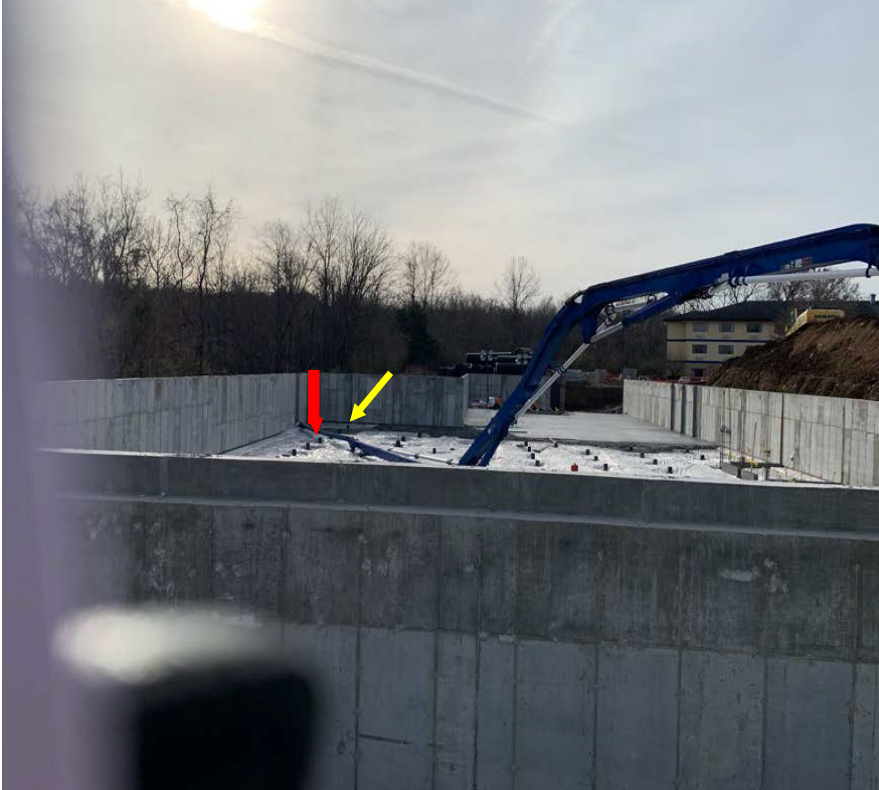
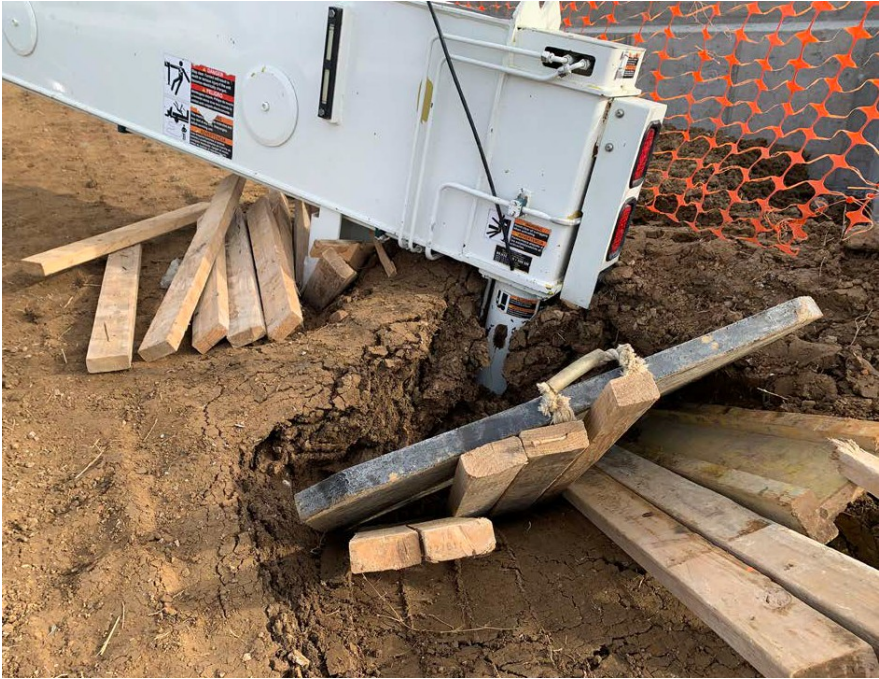
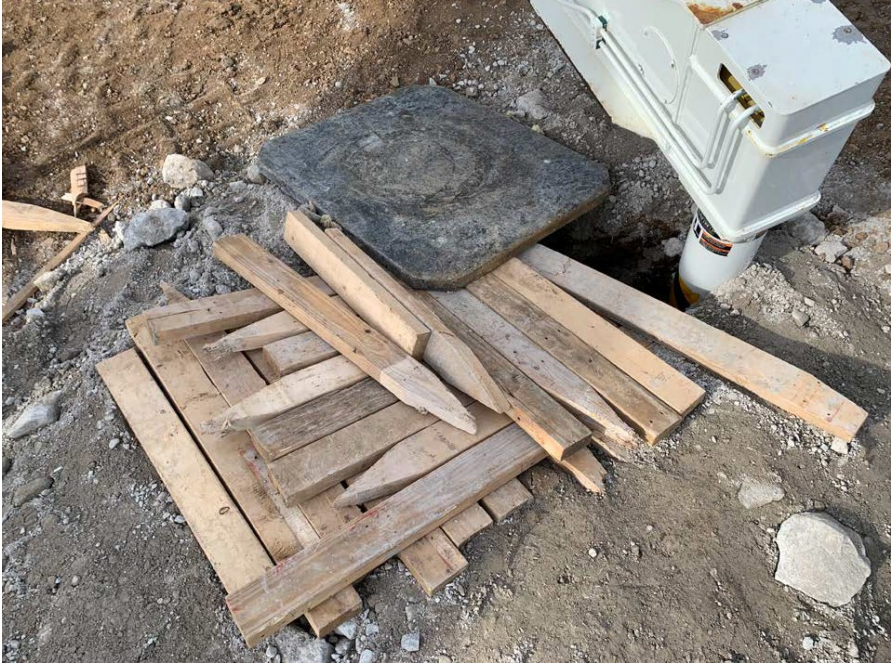
As previously stated, one pour had been completed early the morning of the incident. The truck operator then moved the truck to the northwest side of the job site. The area around the basement wall had been backfilled a couple of weeks prior by another contractor with approximately 11.5 feet of 57 stone gravel with the remaining 16-18 inches on top with soil.

The front passenger outrigger was placed approximately 3-5 feet from the wall and the rear outrigger approximately 2-3 feet from the wall. All four outriggers were placed on 3'x3' rubber outrigger pads. The operator tested the stability of each outrigger by lowering each one

individually until the truck raised off the ground. He also extended the boom over each outrigger to test stability. He determined that the support for the front passenger side and rear outriggers was not adequate. He had an employee add 8 bucket loads of extra rock under where he intended to place the front outrigger pad. He also added 30-2x4s in a criss-cross pattern and a 3'x4'x 5/8" thick piece of plywood under the front outrigger pad. At the rear outrigger he added a mixture of 10-2x4s and 4x4s in a criss-cross pattern under the outrigger pad. The length of all the boards was approximately 48 inches. The operator stated it normally took about 45 minutes to set up the truck, but this time took about 1.5 hours due the extra efforts needed to add support and the lack of light being so early in the morning.

Based on interviews it appears there were indications that the ground conditions were not suitable to support the load placed on the outriggers, but the operator made the decision to proceed. Additionally, it was apparent that the methods used by the operator to set up the concrete boom pump truck did not follow the guidelines in the operator's manual.
