A **20 year old male** employee was **struck by a road grader** while in the process of flagging for dump trucks. The employer was contracted to widen the shoulders of Butler Drive with crusher run gravel. The process involved a dump truck dropping the material, the material being spread into place using a road grader, and finally being compacted using a roller.

46 Struck by Road Grader—Insp#1507304 Rollins Excavating

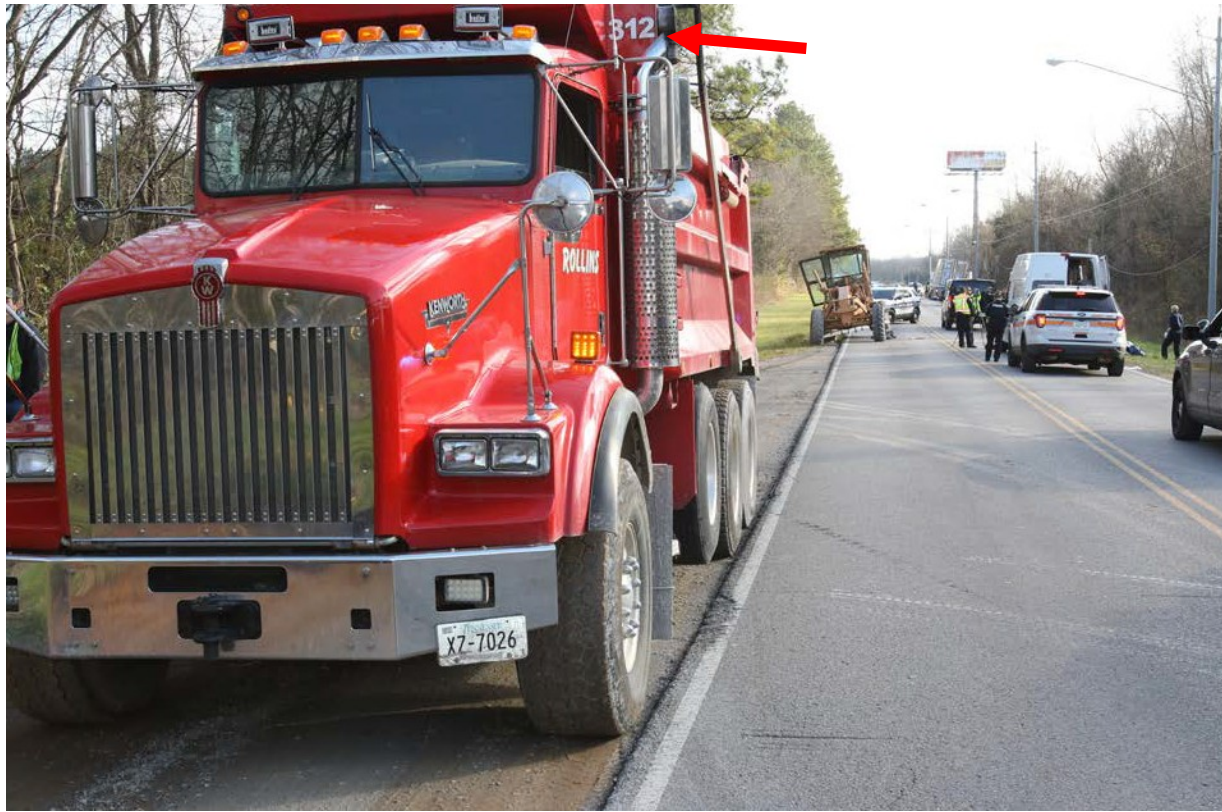
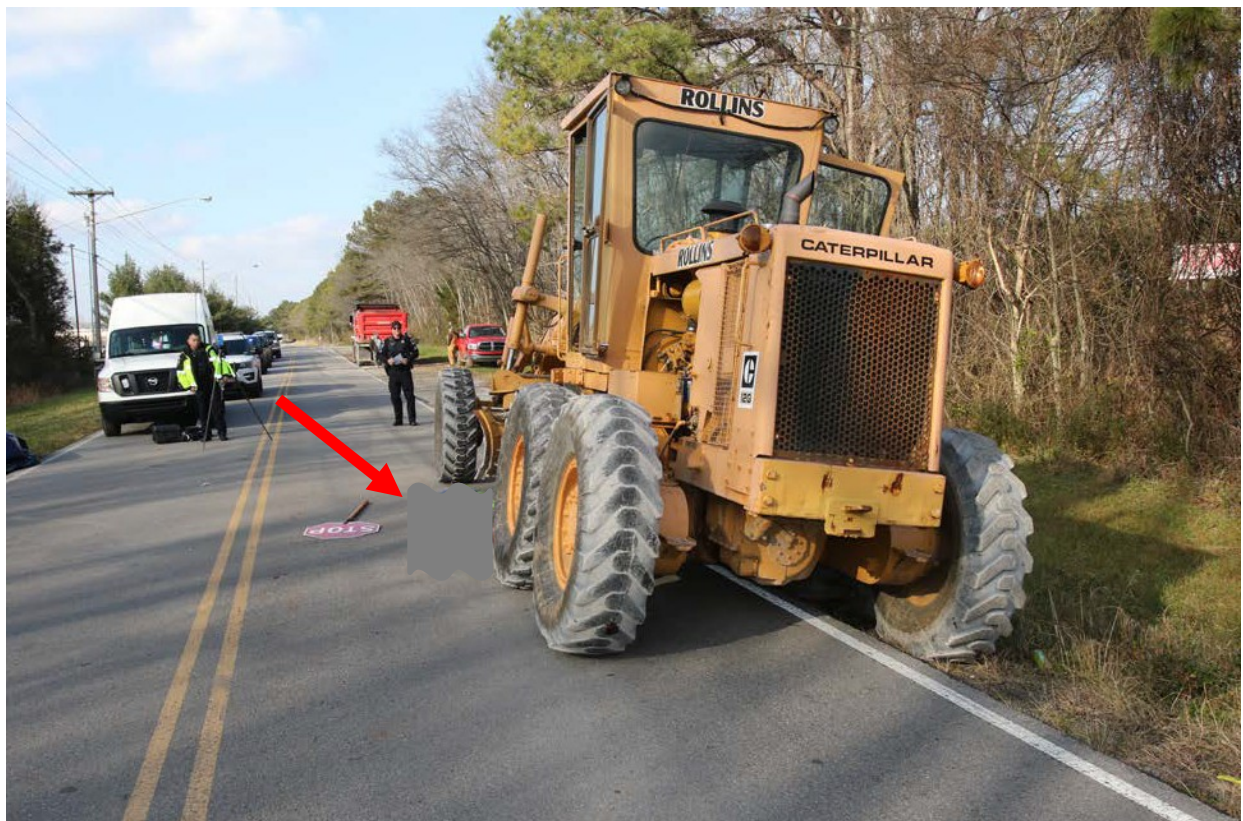
The Caterpillar 12G road grader was equipped with two axles on the rear of the machine just behind the cab. The tires of the machine measured 48" tall and 14" wide and the operational weight of the machine was listed as 31,592 pounds. Pictures indicated that the victim had his back to the machine when he was struck due to tire marks going up the backside of his body causing massive trauma to his body and head.

An inspection of the road grader and two other dump trucks determined that they were not equipped with functional backup alarms. The victim was wearing a high visibility vest at the time of the incident. Also, it was determined that the employer covers pedestrian safety around machinery in safety meetings regularly.

In that a Caterpillar 12G motor grader was operated in the reverse gear without a functioning back-up alarm.
