A **47 year old man** was **electrocuted** while conducting maintenance work on the HVAC unit in an attic of a residence home by himself. He was troubleshooting because the unit was not keeping up with the outside temperatures.

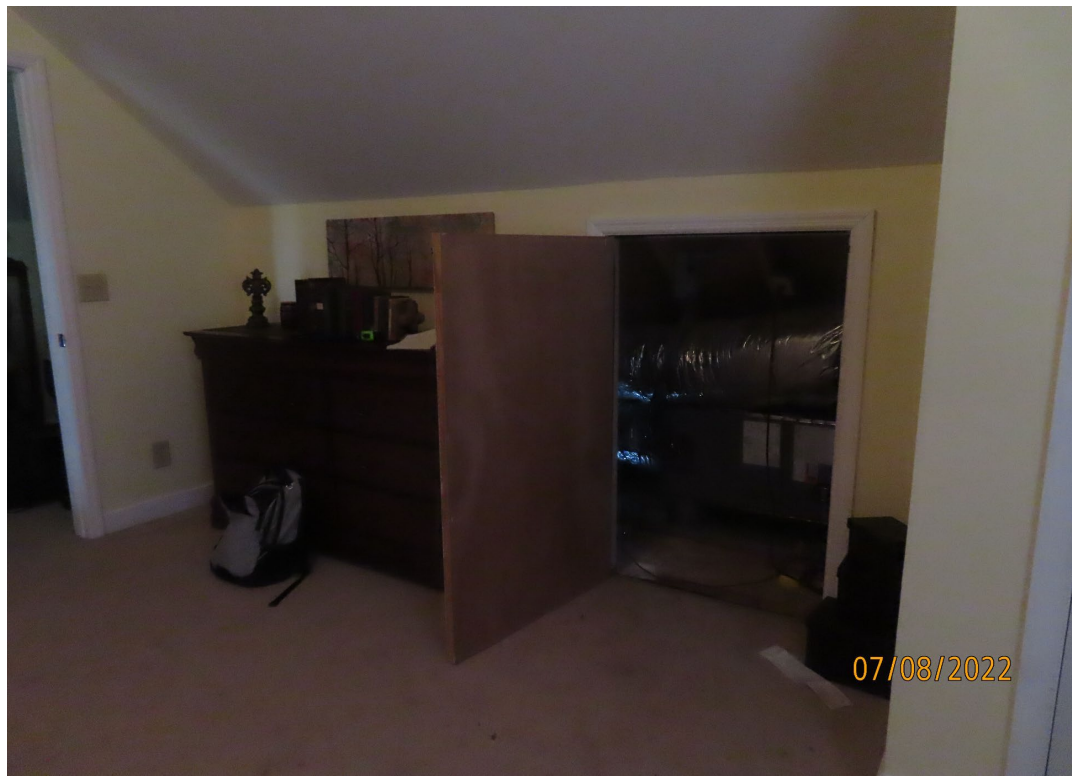
It appears that the victim may have started going through the steps stated above when he contacted the energized duct work. The victim was found to have burn marks on his upper right arm, back of his arm, and across a small area of his abdomen. It is believed that the victim was electrocuted due to the electricity running through the duct work of the HVAC system. An HVAC unit in its completed installation should not have current in the duct work.

After the accident, the homeowner's insurance adjuster sent TOSHA an email explaining that through their investigation it was determined that a dryer circuit passed through the attic near the duct work and may have somehow been compromised whereby energizing the duct work.

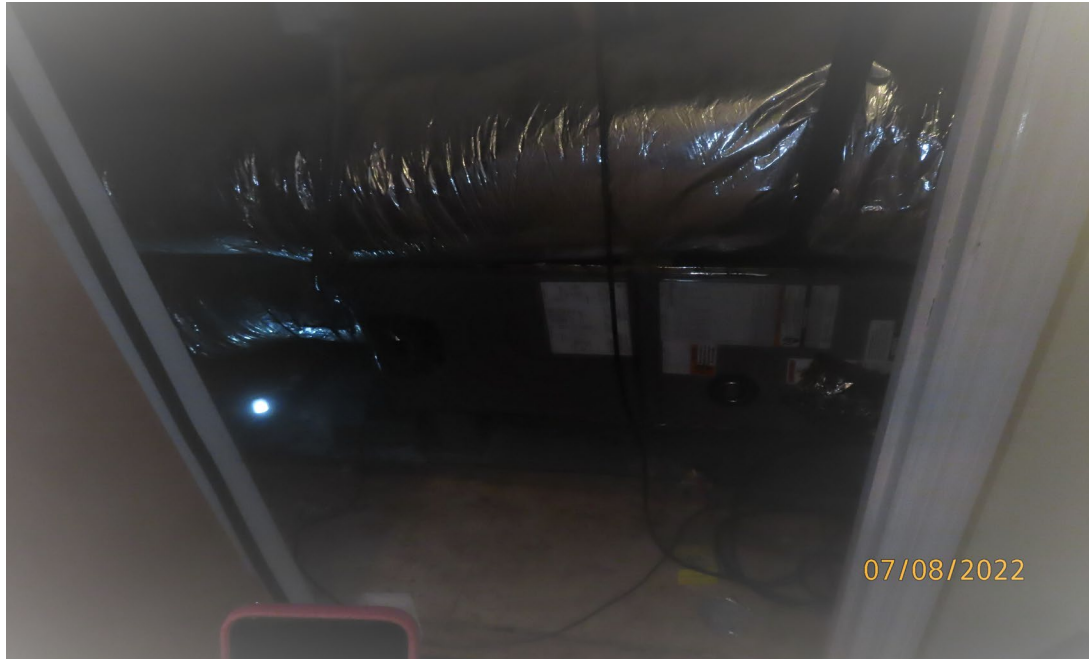
On the day of the accident, it was determined that the victim's temperature clamp was on one of the suction lines (copper line). This would be done to check the temperature of the pipes to see what the unit was doing/diagnosing the unit. First steps to troubleshooting for the unit not keeping cool include hooking up the gauges to see if the refrigerant is low on the outside unit and go outside to check refrigerate pressures. The second step would be to take temperatures on the duct work of the supply and return. To do this, the technician would stick a temperature thermometer in the duct work. This checks the temperature differentials between the furthest point and the closest point to the unit. The third step is to determine duct sizing to see if the duct was the correct size for the home and to see if the right air flow is blowing the correct air for the duct. The HVAC needs to be running when taking temperatures.

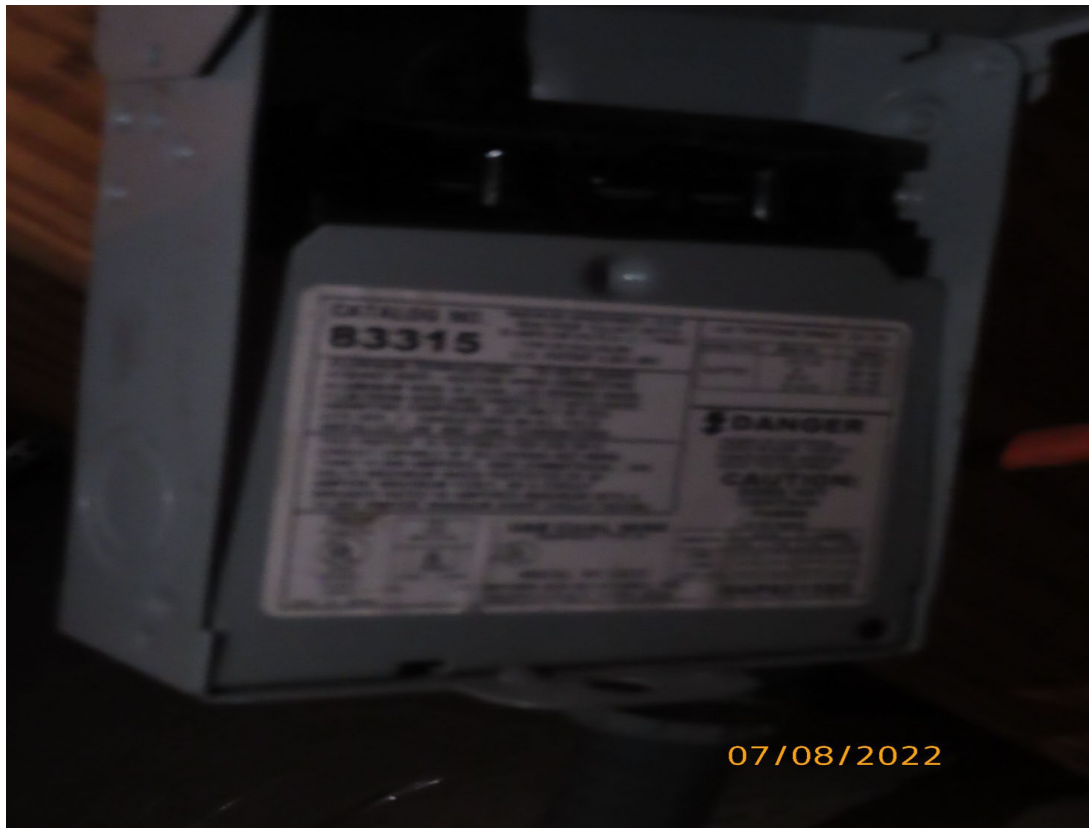
Through interviews, we were informed that the power to the HVAC unit was turned off to the upstairs unit by a detective after the incident. When two Hiller employees came to pick up the work van and victim's tools; the detective used one of the Hiller employee's hot sticks to test the duct work. The hot stick showed the duct work had an electrical current running through it. The detective stated that on the left side about a foot off of the unit there was aluminum tape. He said everything after the aluminum tape tested hot even after shutting off the unit. It was confirmed that there were no panels removed exposing the inner workings of the unit. The unit was intact, as in a final installation, when the victim was found.
