A 20 year old employee was crushed when the lawn mower he was using rolled down an embankment. The employee was mowing a residential yard with a John Deere zero turn riding lawn mower.

Mower Rollover—Insp # 1686168 Hectors Lawn Service, LLC

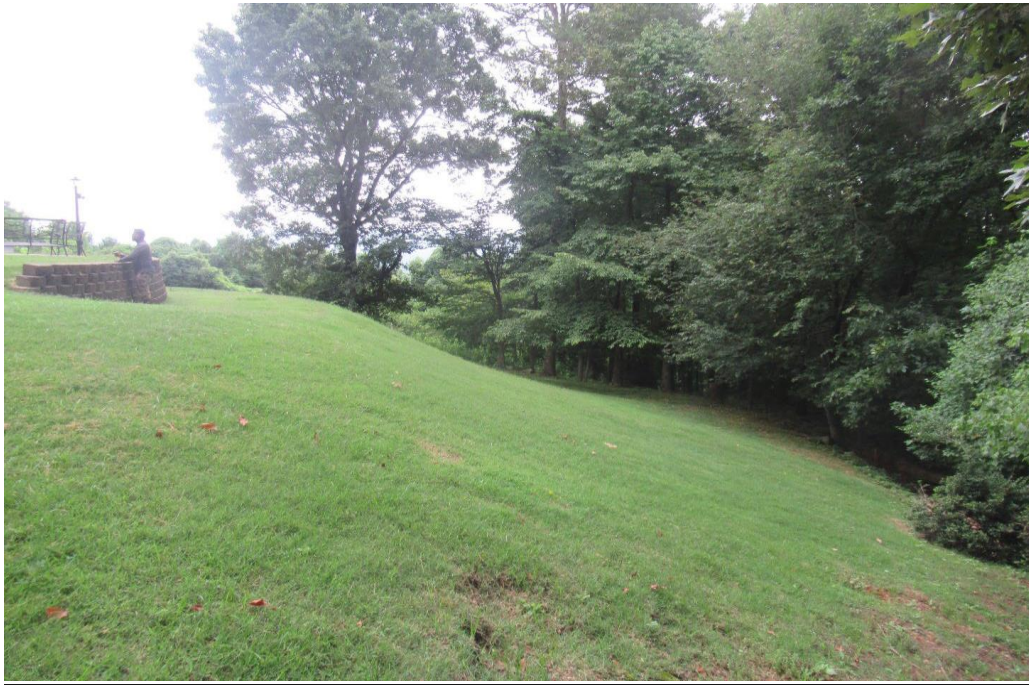
The victim was operating a riding lawn mower mowing along the tree line on the west side of the property directly next to the tree line and near the edge of the embankment. It was at this time that the lawn mower slid or was driven off the edge, causing the lawn mower to flip and roll over, fatally injuring the victim. The roll over protection on the mower was not being used.

In that the John Deere Z930M riding lawn mower was operated without the use of its rollover protection system while on an incline and near the edge of an embankment, which resulted in a rollover and an employee fatality.

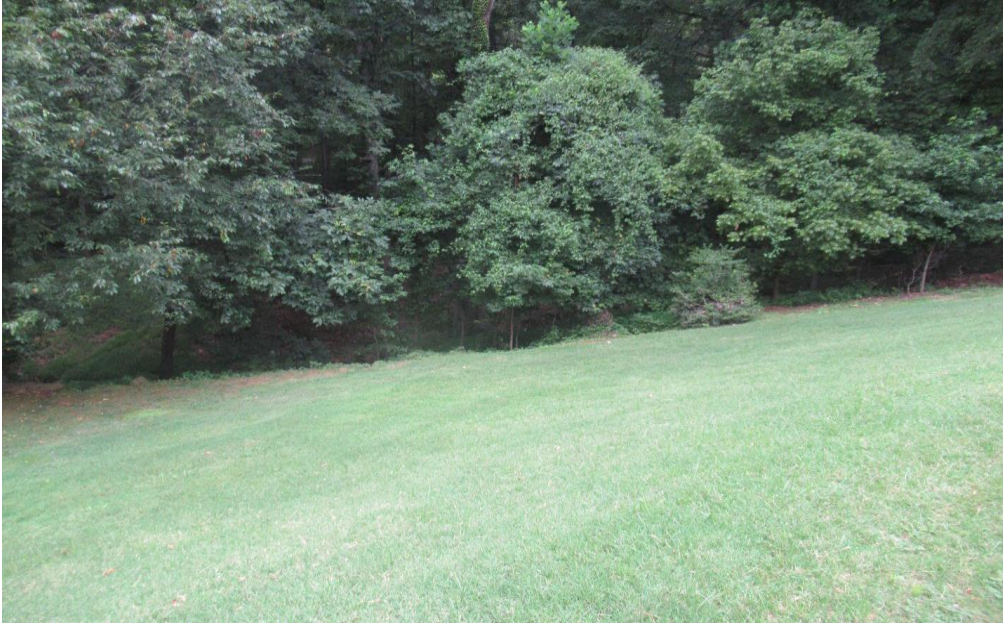
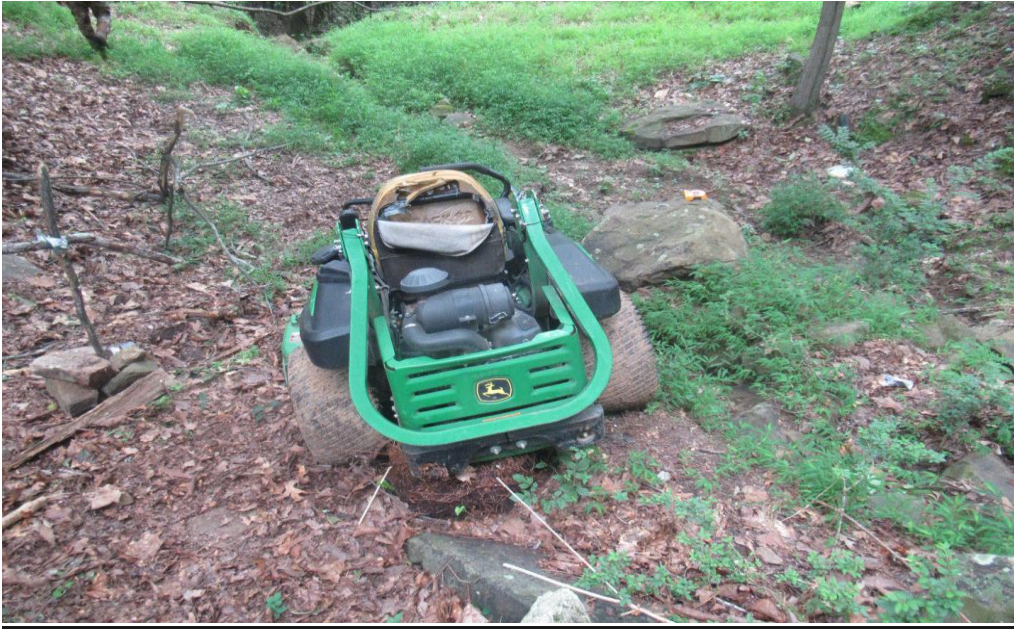
Starting in the backyard, near the pool located close to the center of the property, the yard had an approximate slope of 28-degrees. The closer the yard got to the tree line on the west side of the property the slope became more shallow. The slope changed from approximately 28-degrees to 25-degrees to 22-degrees and to approximately 21-degrees at the tree line.

Once at the tree line, there was a steep embankment. The embankment led to a dry creek bed/ditch for water runoff from the road in front of the house. The embankment had a linear distance of approximately 20-feet and varied in slope. At the top of the embankment, near the start of the yard the slope measured approximately 38-degrees. Going down the embankment the slope became more shallow from 38-degrees to approximately 35-degrees before leveling out near the base.
