#6: Struck By – Inspection #317680056

A **51 year old male** employee was struck by the mast of a forklift. An employee was repairing a hydraulic fitting on the main mast cylinder of a Toyota forklift. The operator of the lift elevated the forks up and set them on top of a CONEX shipping container which was 101” above the ground. The maintenance forklift superintendent proceeded to remove the fitting from the hydraulic cylinder while being positioned below the raised mast and dual loader attachment. After diagnosing the problem as being a leaking O-ring, the superintendent went into the shop area and obtained the correct O-ring and returned to the lift to install it and the fitting back on the cylinder. He again was positioned under the elevated mast and the dual loader attachment. As he started to replace the fitting the mast and dual loader attachment moved from the top of the shipping container they had been resting on and struck the superintendent in the back, pinning him between the pallet of material he was kneeling on and the mast and attachment.

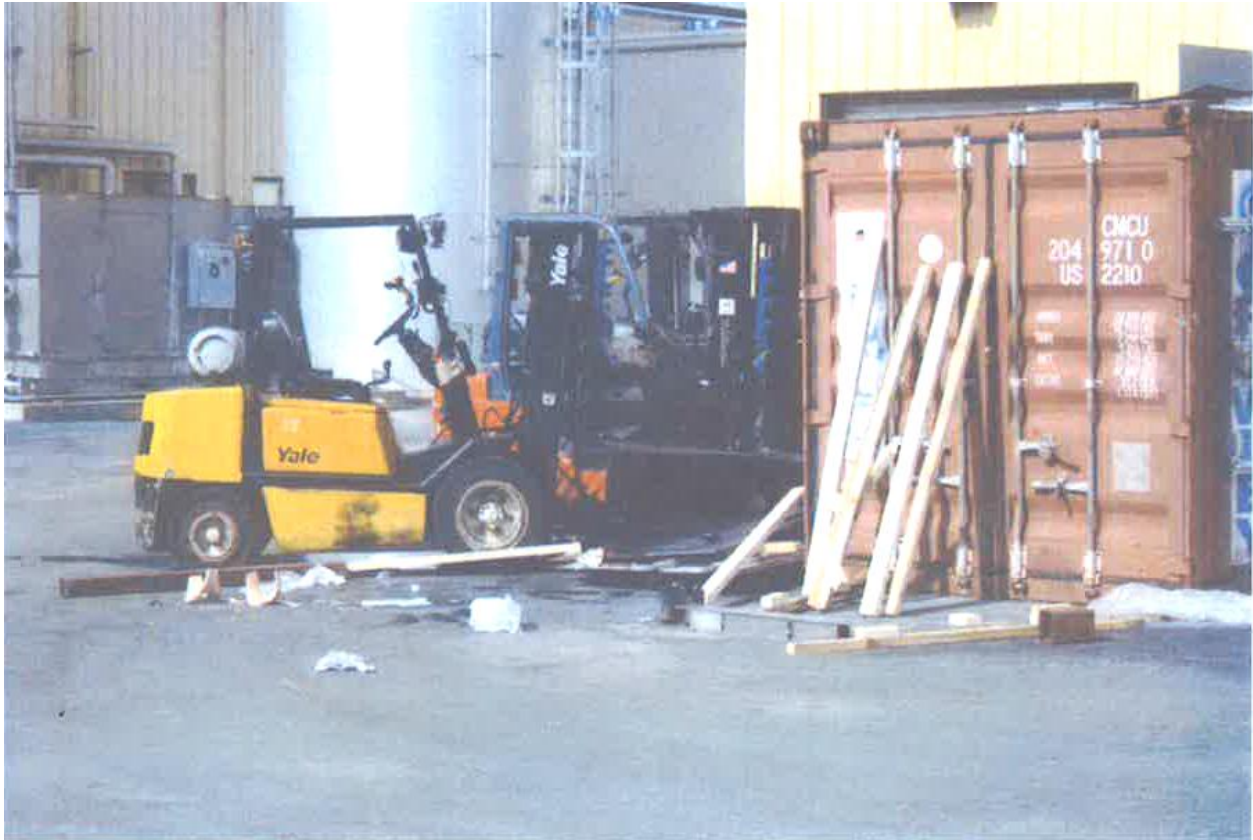
Photo 1 of 1: The employee was struck in the back by the mast of a forklift

Item 2a 1910.147(c)(4)(i)	Procedures were not developed, documented, and utilized for the control of potentially hazardous energy when employees were engaged in activities covered by this section: In that the employer did not develop and follow a specific procedure for the control of stored energy while the employees were required to perform service and/or maintenance on the powered industrial trucks.

Item 2b 1910.178(m)(2)	Persons were allowed to stand or pass under the elevated portion of the truck, whether loaded or empty: In that the maintenance employee was allowed to pass under and work from a position that was under an elevated portion of the lift while repairing the hydraulic system of the lift.
Item 2c 1910.178(m)(5)(iii)	When the operator of an industrial truck was dismounted and within 25 feet of the truck still in view, the load engaging means was not fully lowered, controls neutralized, and the brakes set to prevent movement: In that the operator of the Toyota powered industrial truck was off the truck and in view of it and did not lower the forks to the ground, but instead has them resting on the top of a shipping container while the hydraulic system was being worked on.
