**22 Fall into excavated crevice – Inspection #1170653**

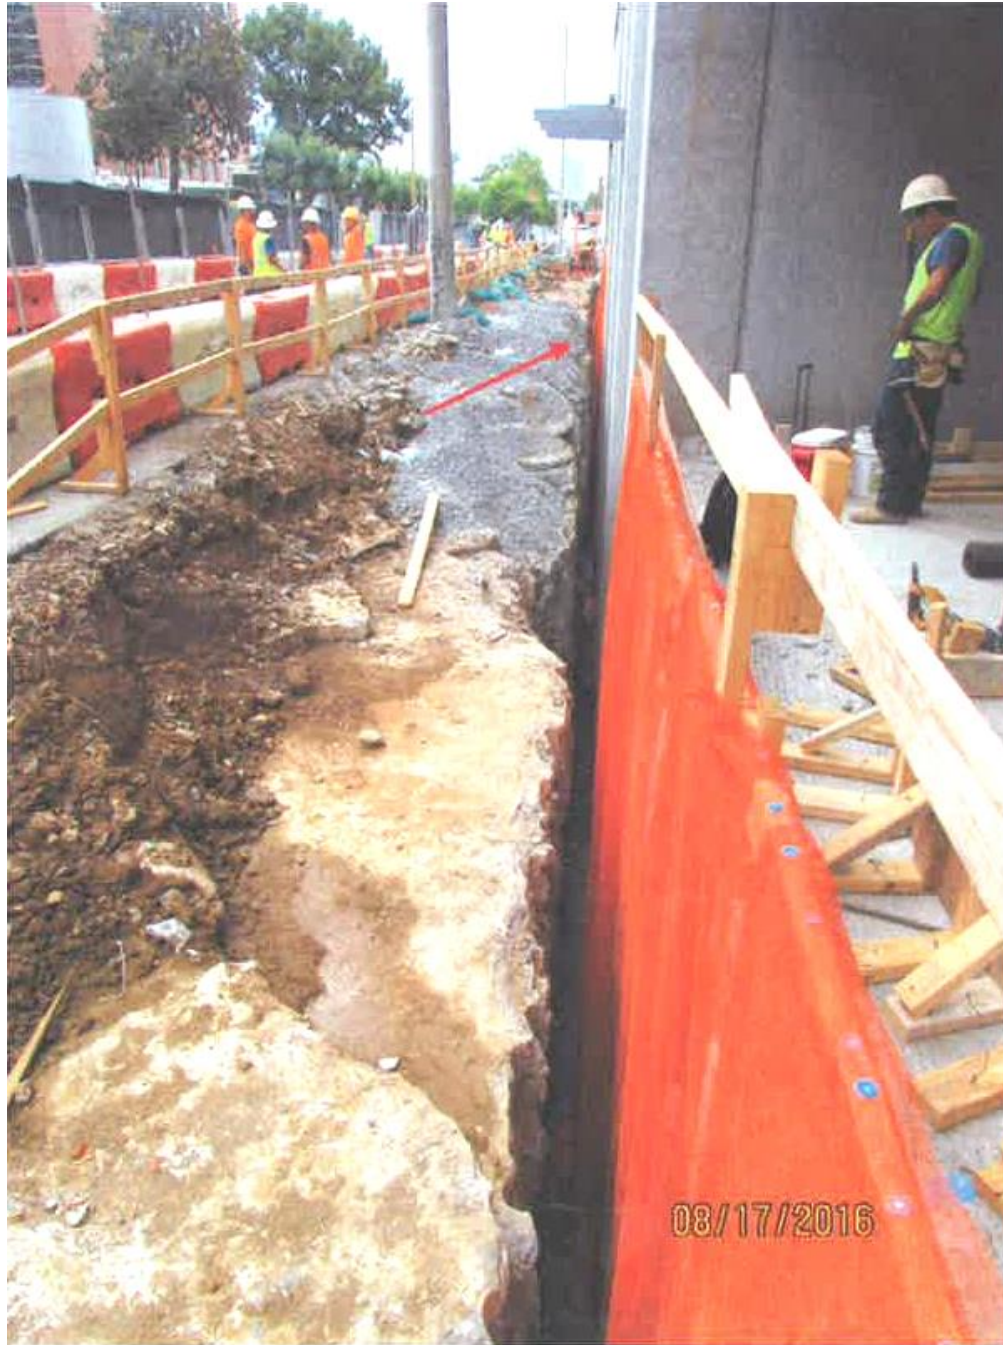
A **69 year old male** employee was fatally injured when he fell into a crevice 24 inches wide, 200 foot long, and 22 feet deep. On the day of the incident the victim, a masonry superintendent, was assisting the forklift operator in the placement of a Kawasaki Gator onto the north side of the parking garage. In doing so, the victim entered a barricaded area protecting the crevice between the parking garage block wall and bedrock. Instead of using the fabricated bridge that spanned over the crevice onto the parking garage floor, the victim attempted to jump the over the excavation into the main deck of the parking garage. As he attempted to jump over the crevice and guard rail, he lost his balance falling between the garage block wall and the bedrock. The victim suffered internal injuries, a fractured hip, and succumbed to his injuries 15 days later.

Photo 1 of 2 – The red arrow indicates where the victim fell 22 feet deep into the crevice.

29 CFR 1926.501(b)(1)	Each employee on a walking/working surface (horizontal and vertical surface) with an unprotected side or edge with is 6 feet or more above a lower level was not protected from falling by the use of guardrail systems, safety net systems, or personal fall arrest systems. In that the employer did not have effective fall protection while attempting to cross a 24 inch wide by 22 feet deep crevice located between the prefab structure and rock wall along the north side of the parking garage.
-----------------------	---

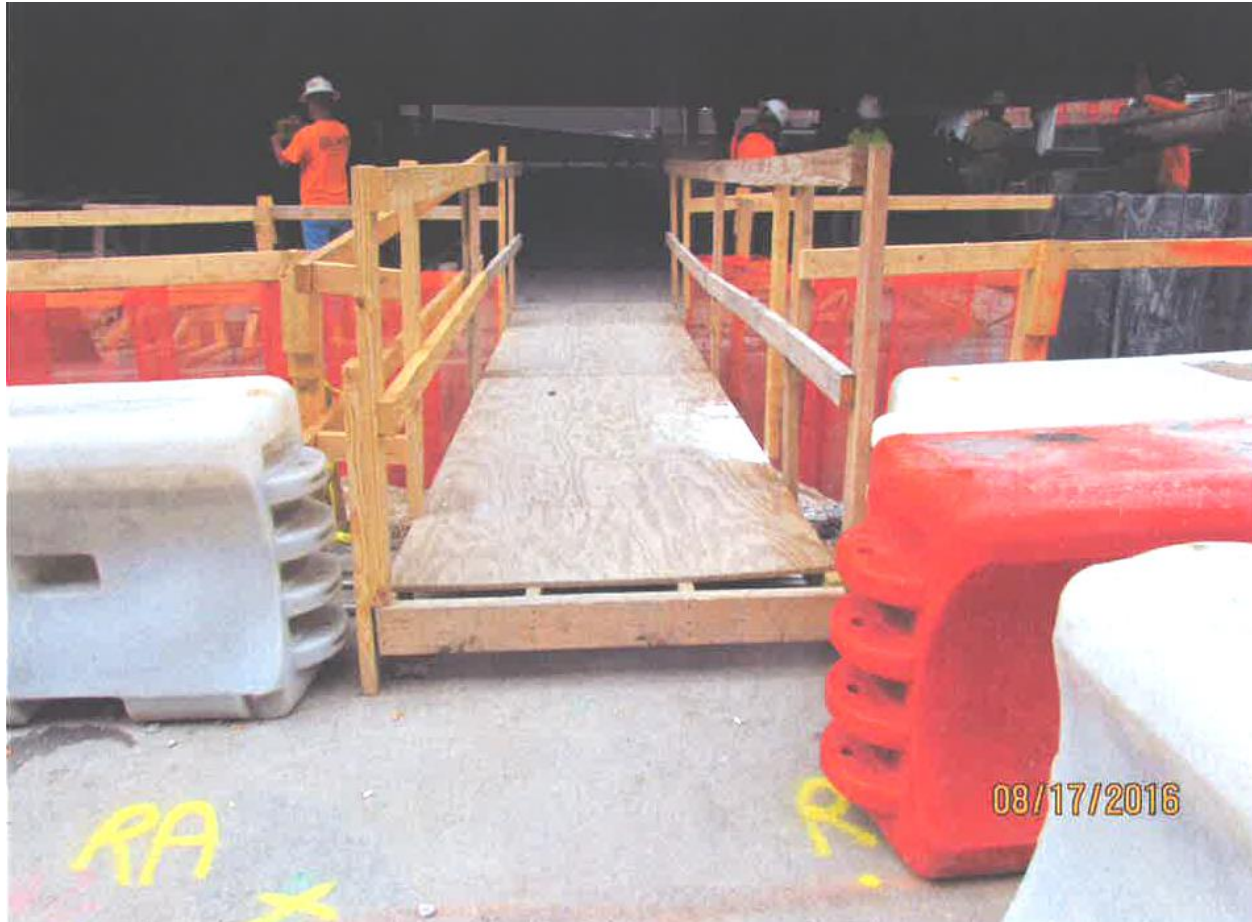
Photo 2 of 2 – The wooden bridge built for employees to enter the parking garage located approximately 60 feet for the area where the incident occurred.
