8 Struck by super-sack of sand – Inspection #1146807

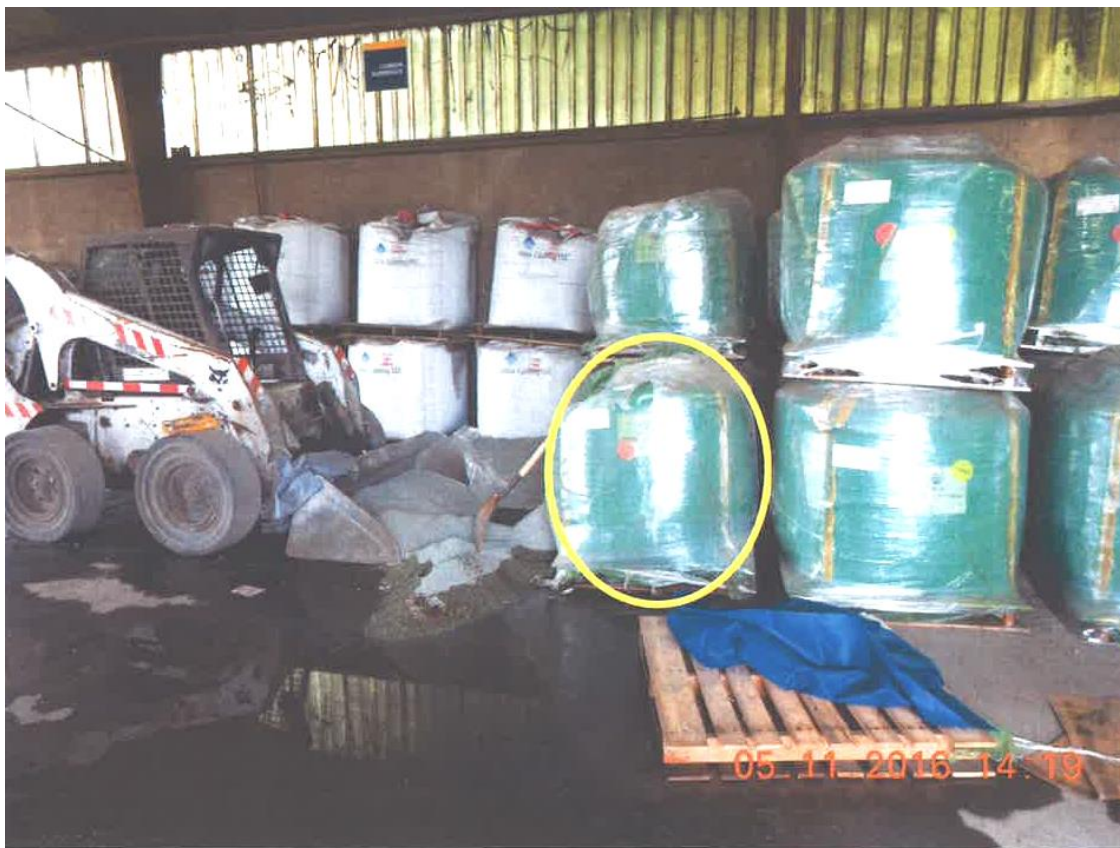
A **56 year old male** employee was fatally injured when he was struck by a super-sack of sand burying him underneath. On the day of the accident, the victim attempted to patch a hole in a super-sack containing “tap hole” sand used in an electric arc furnace during the molten metal pouring process. The super-sacks were stored shrink wrapped onto pallets, and stacked two pallets high. As the victim was patching the hole at ground level, the sack shape changed, making the second tier of super-sacks unstable. The 4000lb super-sack stored on top struck the victim burying him underneath.

29 CFR 1910.176(b)	Material stored in tiers was not stacked, blocked, interlocked or limited in height so that it was stable and secure against sliding and collapse. In that 4000lbs super-sacks of tap hole sand located in the Brick Shed were double stacked creating an unstable condition which exposed employees to a crushed by hazard.
--------------------	--

Photo 1 of 1 –The lower tiered super-sack of tap hole sand (yellow circle) where the hole was located.
