16 Crushed between trailers – Inspection #1234752

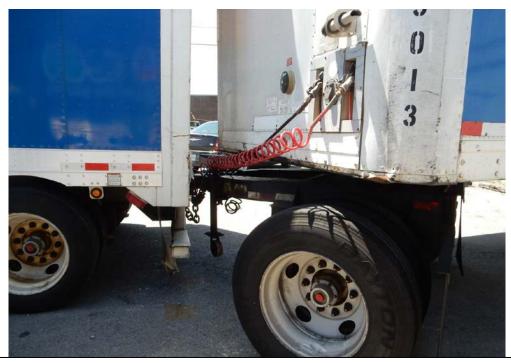
A **39 year old male** employee was fatally injured while connecting a tandem trailer rig when he was crushed between the two trailers. It was determined that the victim failed to set the parking brake of the tractor before exiting to connect the second trailer. Based on the position of the victim's body it suggests that he was in the process of connecting the electrical line when the rig built up enough pneumatic pressure to release the brake of the second trailer. The pneumatic brake system disengages the brake when air is supplied to the system and engages the brake when no air is supplied. Therefore, until the brake on the second trailer released, this brake was holding the entire rig in place. Due to the parking brake of the tractor not being engaged when the trailer brake released, both the tractor and trailers moved backwards causing the first trailer to jack-knife into the second trailer. The victim became pinned between the two trailers.

Photo 1 of 1 – Photo shows the area where the victim was attempting to connect the tandem trailers. The victim became pinned between the two trailers when they rolled backward after the trailer brake released.

In that an employee was exposed to crush between hazards while connecting the second trailer in a tandem trailer set, resulting in fatal injuries. One feasible and acceptable abatement method to correct this hazard would be to ensure the parking brake is always engaged before exiting the truck.
