A **53 year old male** employee was **crushed** between the refrigeration unit of the trailer and the smokestack on the cab of a yard truck while another employee was backing the truck into place.

53--Crushed by--Insp # 1564415Performance Food Group Inc

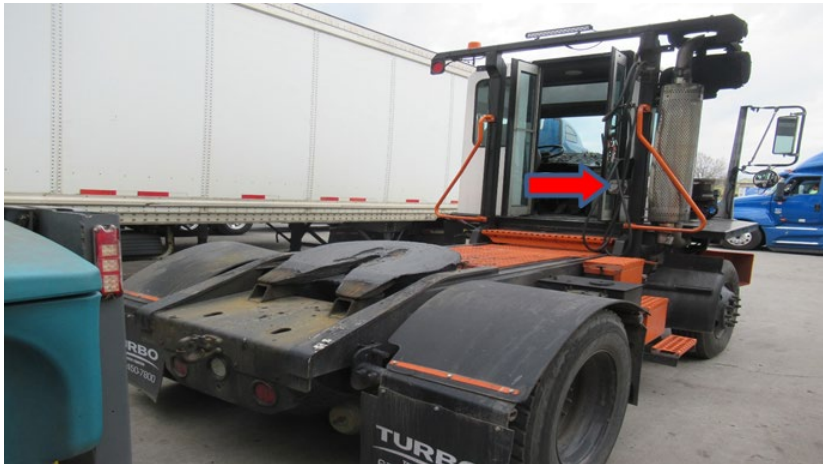
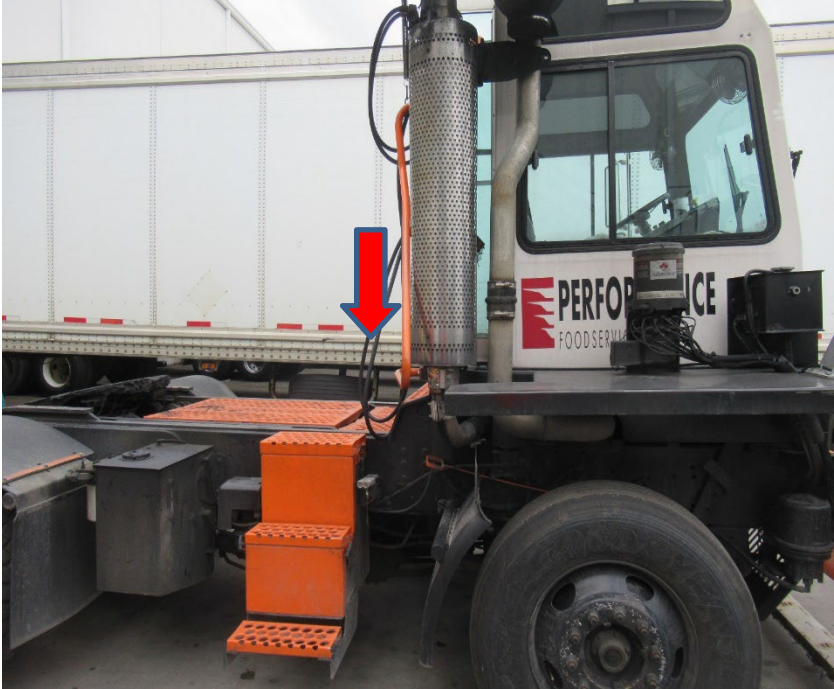
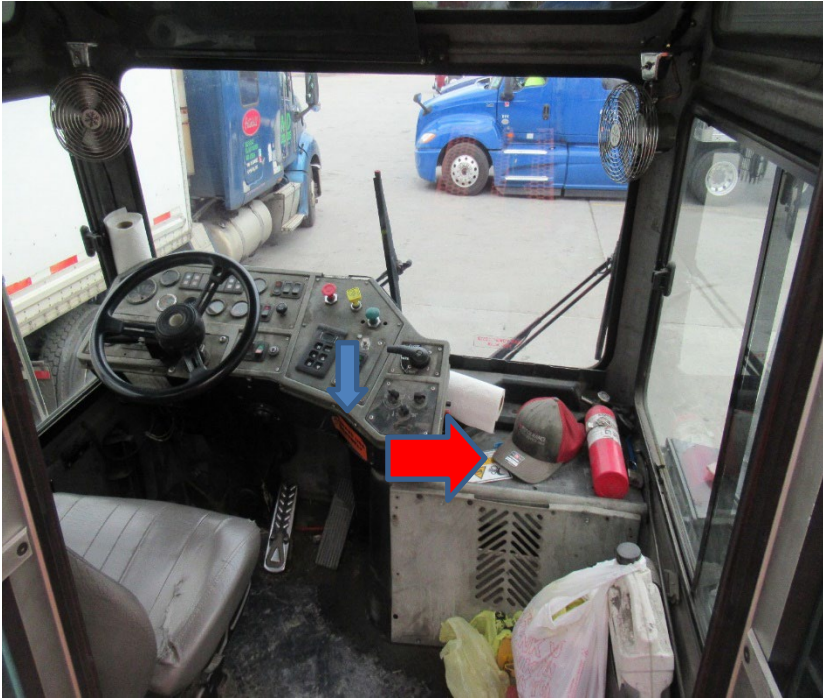
The platform of the Yard Truck measures 42 inches high, 43 inches wide, and is 60 inches long measured from the cab to the back of the fifth wheel. The cab of the TICO Pro-spotter yard truck is only designed to accommodate the driver, as there is only one seat and seat belt. During interviews it was determined that common practice was for the trainer to sit on the dash in the cab while the Yard truck was in operation.

On this day, the victim stood on the platform to give directions. While driving in reverse to connect the trailer, the kingpin on the trailer hit the edge of the fifth wheel on the Yard Truck causing it to slide off the fifth wheel and become lodged behind the fifth wheel. The trailer was designed with a refrigeration unit that extended out an additional 23 inches from the trailer. When the kingpin was lodged behind the fifth wheel, the victim was pinned between the refrigeration unit of the trailer and the smokestack on the cab of the Yard Truck. The Trainee could not pull the Yard Truck forward because the kingpin was lodged behind the fifth wheel. The only entrance to the Yard truck is the door located on the platform which was blocked by the trailer. The Trainee had to climb out the window of the Yard Truck to get assistance. Other employees ran over to help raise the trailer so that the kingpin would clear the fifth wheel and the Yard Truck could be moved away from the trailer.
