#27: Explosion – Inspection #1010771

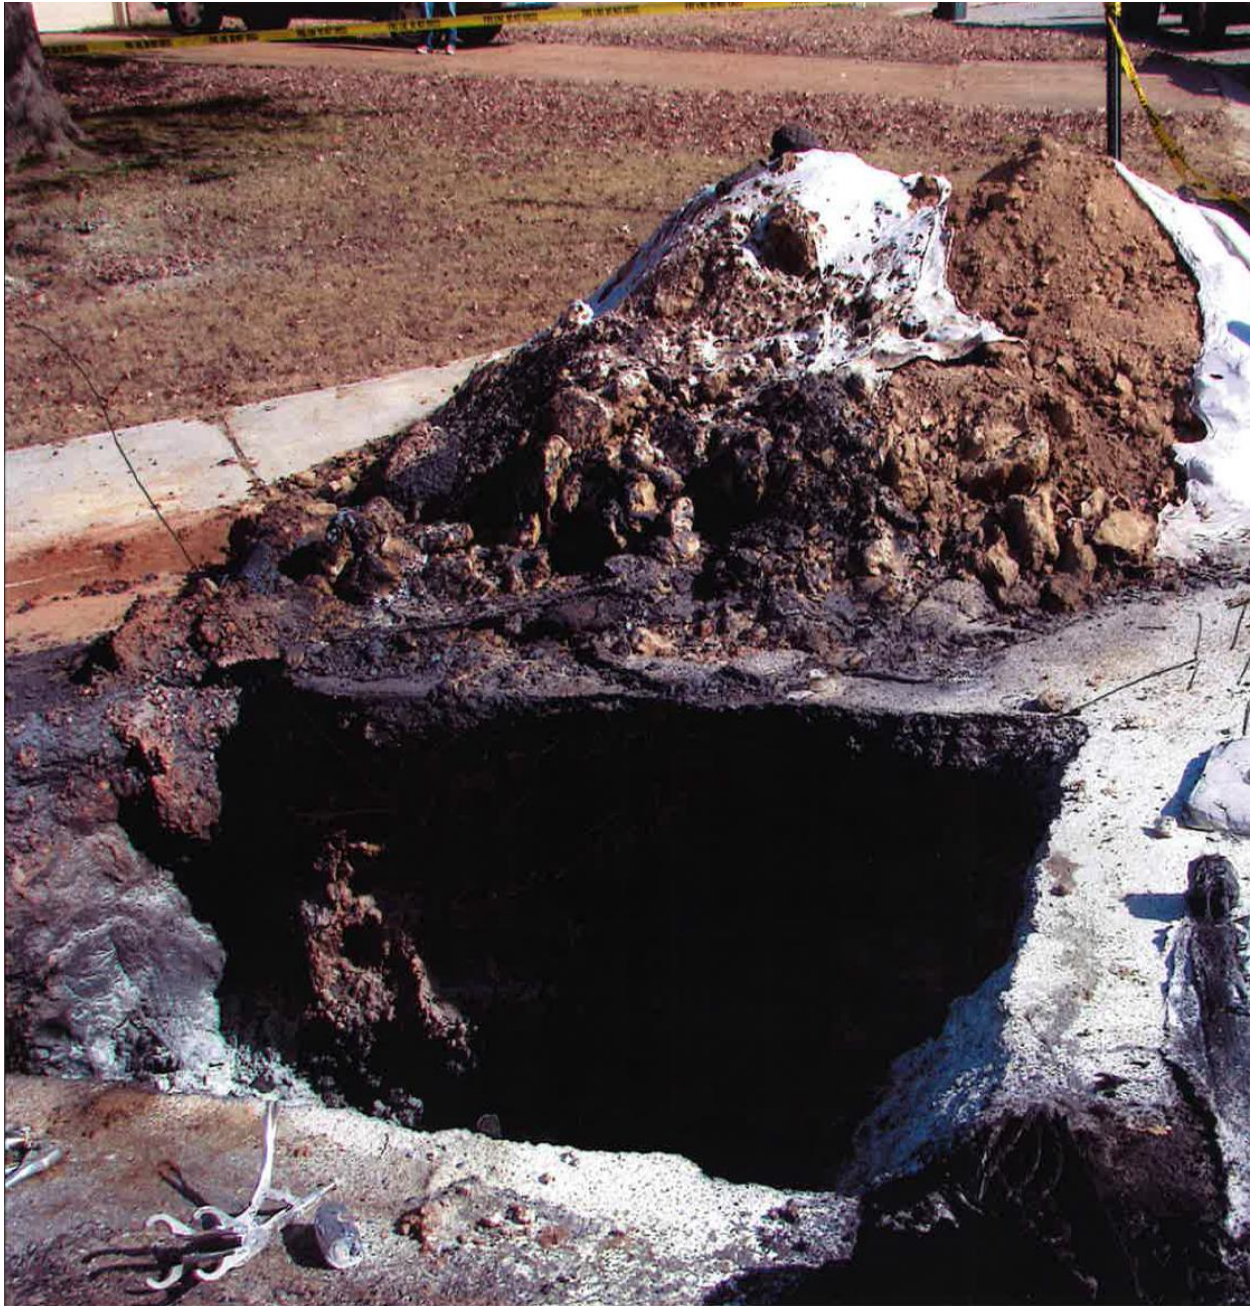
Photo 1 of 1: Natural gas explosion

A 35 year old male employee died due to injuries during an explosion. Five employees were making routine repairs on a 2” polyethylene (PE) gas distribution main when natural gas was released into the work area resulting in a fire. The employees were replacing a section of the 2” PE line approximately 4’ long that included two tee fittings. During the interval between removing the old section and installing the new pipe natural gas began entering the work space, ignited most likely by static discharge, and resulted in injury to the crew members. Three employees were hospitalized and one died nineteen days later.

Item 1 T.C.A. 50-3-105(1)	The employer did not furnish to each of his employees conditions of employment and a place of employment free from recognized hazards that are causing or likely to cause death or serious physical harm to his employees. Employees were exposed to an explosion hazard while making repairs to a 2” polyethylene high pressure natural gas main. A possible abatement method would be to conduct additional training for all Gas Division employees to include: 1) Hazards of static ignition of natural gas; 2) MLGW General & Gas Division Safety Manuals; 3) Proper response to abnormal operation conditions encountered; 4) Ensure total control of gas flow at the squeeze off point.

Item 2 1910.147(c)(4)(i)	Procedures were not developed, documented and utilized for the control of potentially hazardous energy when employees were engaged in activities covered by this section. The gas flow had not been controlled and locked out in order to prevent the leakage of natural gas at the repair location on the main.
