#### 28 Struck by wheel loader – Inspection #1186869

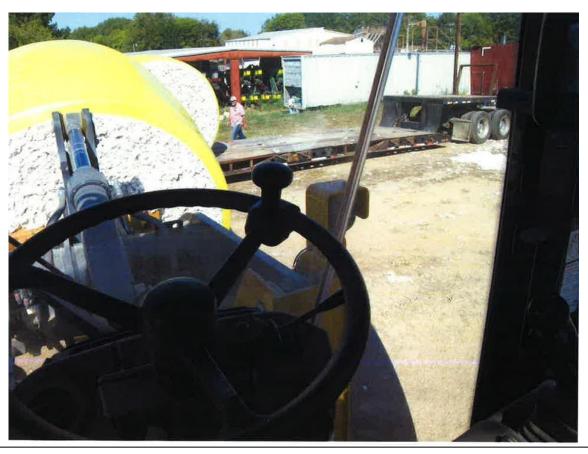
Photo 1 of 1 – View from the operator's seat of the John Deere 544K wheel loader with a round bale of cotton loaded on the four-tine bale spear.

TCA 50-3-105(1)	The employer did not furnish employment and a place of employment which were free from recognized hazards that were causing or likely to cause death or serious physical harm to employees in that employees were exposed to. In that an employee was struck by a John Deere 544K wheel loader that was driven by an untrained operator while in the process of transporting a round cotton bale from the bale staging yard to the cotton gin's feeder. Among other methods, one feasible and acceptable method to correct this hazard is to train all John Deere 544K wheel loader operators to safety operate the
	wheel loader in and around the cotton gin.
