15 Electrocution – Inspection #1234573

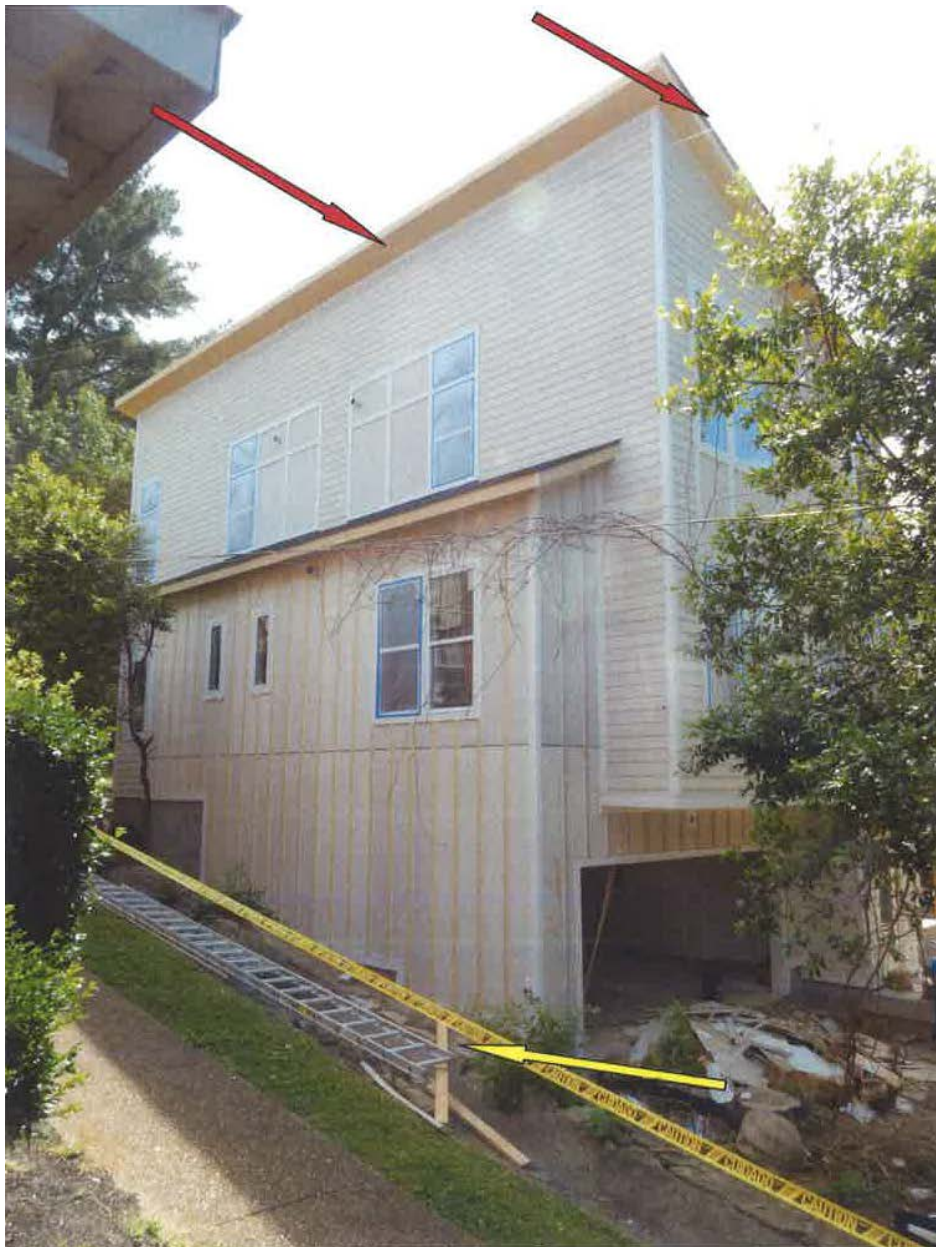
A **30 year old male** employee was fatally injured when he was electrocuted while positioning a 40 foot aluminum ladder for the purpose of painting the exterior of a residential home. On the day of the incident, two painters were moving a 40 foot aluminum ladder along the West side of a newly constructed home. The witness stated they were trying to move the ladder around the electrical line and “were not sure if it was turned off”. The ground was uneven and the ladder slid/moved contacting the powerline. One employee was able to let go of the ladder as it continued to move, but the victim could not let go of the ladder.

Photo 1 of 1 – West side of the house where the employees contacted the power line (red arrows) with the 40 foot aluminum ladder (yellow arrow).

29 CFR 1926.416(a)(1)	<p>Employees were permitted to work in proximity to electric power circuits and were not protected against electric shock by de-energizing and grounding the circuits or effectively guarding the circuits by insulation or other means.</p> <p>In that two employees were permitted to work in close proximity to an energized electrical line at 13,800 volts while they were positioning a 40 foot aluminum extension ladder to paint the exterior of the house. The electrical line was positioned approximately 7-8 feet away from the house, running parallel to the side of the house.</p>
-----------------------	--

29 CFR 1926.1053(b)(12)	<p>Ladders used where the employee or the ladder could contact exposed energized electrical equipment did not have nonconductive side rails.</p> <p>In that a 40 foot aluminum extension ladder was being set up in close proximity of an electrical power line (13,800 volt) by two employees when the ladder came into contact with the line.</p>
-------------------------	--
