A **33 year old male** employee was crushed between the door and the frame of the press by the door of a press as it closed. The employee apparently leaned back into the point of operation area of the press to wipe a part of the equipment.

15 crushed by press door--Inspection # 1426856 Feintool

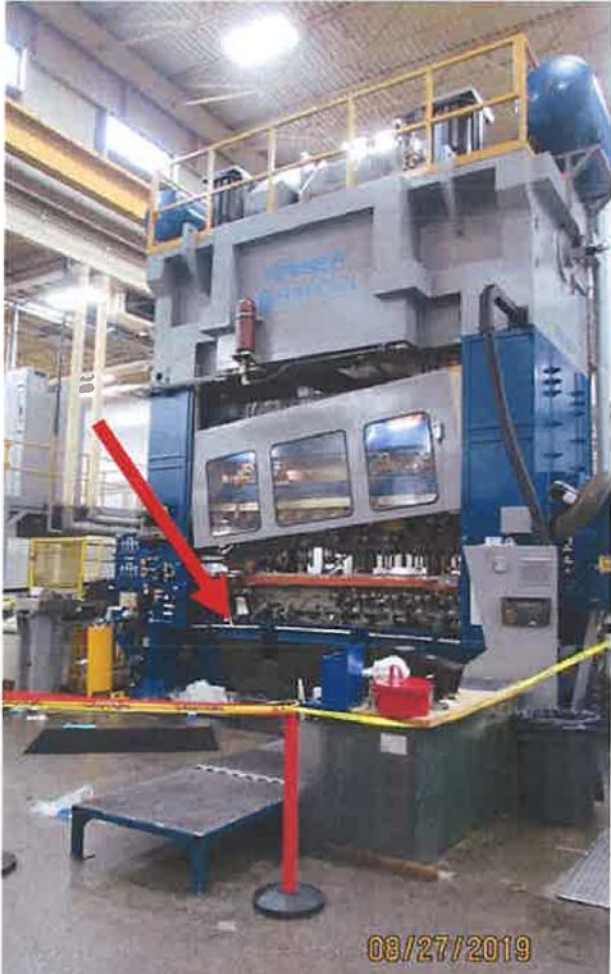
15 crushed by press door--Inspection # 1426856 Feintool

At the time of the accident however, the victim was able to press the down button to activate the closing of the movable barrier guard (door), let go of the button, walk over to the door area of the press, and lean into the press area underneath the door, all while the door continued to lower. As the door closed it pinned Mr. Hester between the guard door and the frame of the press resulting in fatal injury.

In that the safety switch on the moveable barrier guard was not functioning properly to prevent the guard door from continually closing on the Kaiser 500-1 hydraulic power press and had not been identified during periodic and/or maintenance inspections.

In that the moveable barrier guard that protected the operator from the point of operation was not properly functioning as a safety switch was bypassed. A press operator was pinned between the protective door on the Kaiser 500-1 mechanical hydraulic press and the frame of the press.
