Crushed—Insp #1545152 Packaging Corporation of America

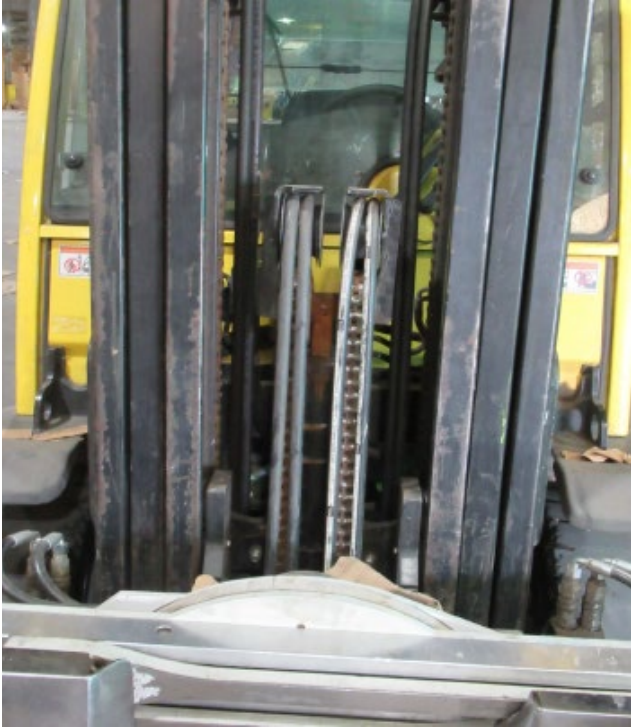
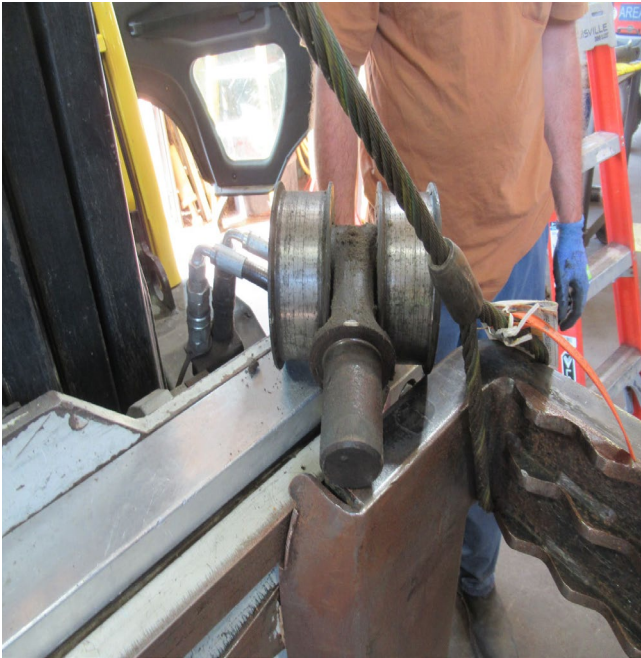
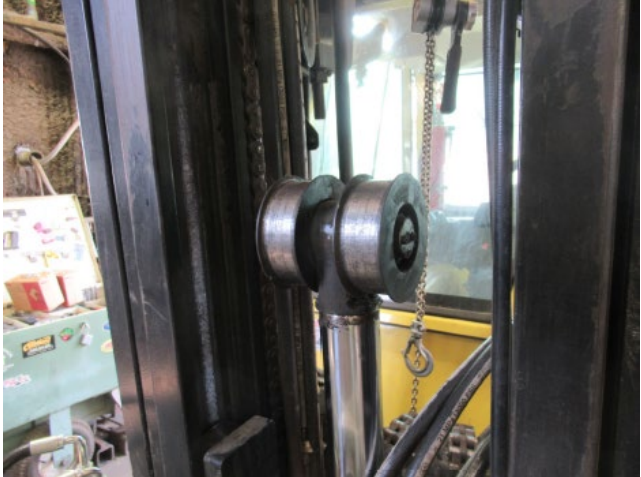
During the inspection, it was observed that the pin and head assembly which is intended to sit on the top of the first mast section hydraulic cylinder was not in place. This pin and head assembly were found to have been removed from the top of the cylinder and were sitting between the forklift mast and cab, hanging by 2 hydraulic hoses and chains. A broken bolt was also observed to be on the floor inside the clamp assembly near the right-side clamp. This bolt was discovered to have been sheared/ broken. This broken bolt was one of four bolts that hold the clamp assembly to the block that is placed on the forklift mast. A yellow prybar was found on the floor approximately 4.5 feet away from the forklift's left side lying on the floor.

It was determined the most likely cause of the pin and head assembly to be removed from the mast cylinder was that the employee placed a bale of recycled material on top of other bale(s) and while attempting to maneuver his clamps/ mast, a piece of wire, from one of the bales, hung in the pin and head assembly pulling it out. If this were the case, it would prevent the first stage mast assembly from lowering all the way to the ground. It is believed the victim could not lower the mast to the floor; it is estimated to have stopped at about 5-6' off the ground. The victim may have been using the crowbar in attempt to reinstall the pin and head assembly when the clamp assembly fell on top of him, crushing him.
