Fall from scaffold—Insp # 1625611 SCM Construction Inc.

A **42 year old male** employee **fell 5'7"** from a baker scaffold when one of its wheels fell in to a hole in the floor while it was being relocated. He succumbed to his injuries a week after the incident.

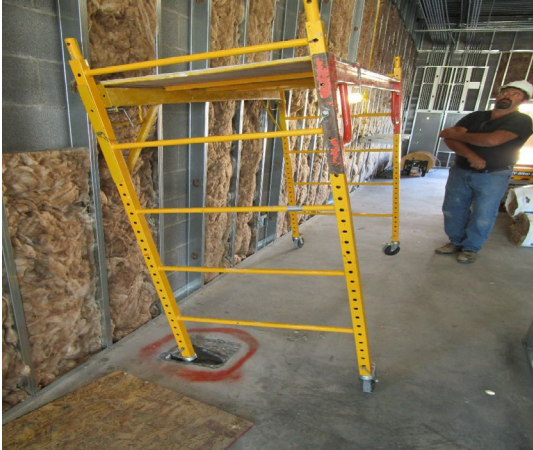
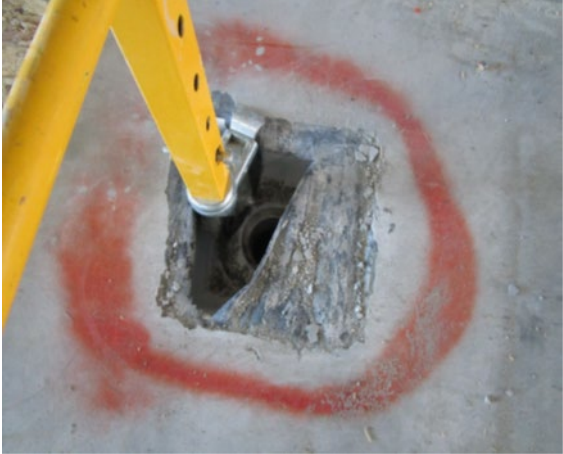
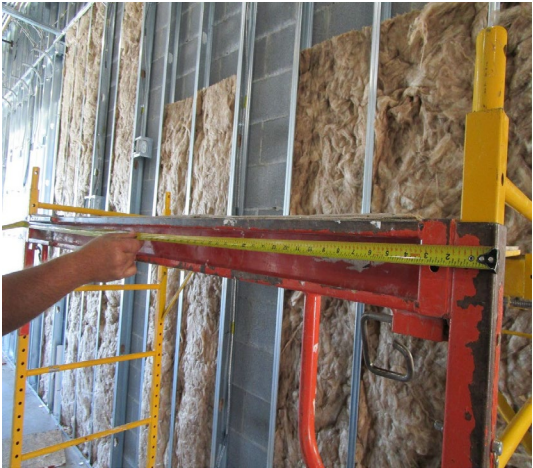
An interview of the plumbing contractor revealed that it is customary to cover the floor drains (including the subject 9"x 9" x 5" porcelain floor drain) with black tape. There are two reasons for the tape: one, to keep out trash and debris that could potentially clog the drain; two, to keep malodorous sewer gases contained because the drain is actively connected to the city sewer. It was explained that next, the concrete contractor would pour the slab. After the slab had cured, a polish was performed on the concrete. After the pour and the polish, the black tape was no longer black in color; it appeared gray like the rest of the slab. Therefore, the floor drains were not as noticeable.

The General Contractor confirmed that the slab was slightly overpoured and he showed the CSHO other areas in the store's floor that were also affected. Interviews revealed that the floor drain's location was essentially concealed because it looked like the rest of the slab due to the slight overpour and concrete dust from the polishing operations. When the employee scooted down the wall to a new location, the left-front wheel penetrated through the thin layer of concrete and black tape that covered the floor drain's opening. The baker scaffold's northwest corner tilted forward which likely caused the victim to lose his balance, fall backwards, and hit his head on the concrete.

In that the caster wheel locks on a 5' 7" baker-style scaffold were not engaged to prevent movement while in use when installing metal studs to a block wall at a worksite.

In that an employee working to install metal studs was riding a baker scaffold on a concrete surface that had a hole, a 9" x 9" x 5" porcelain floor drain.
