## 1 Fall through skylight—Insp #1721951 Big G Metal Works Inc.

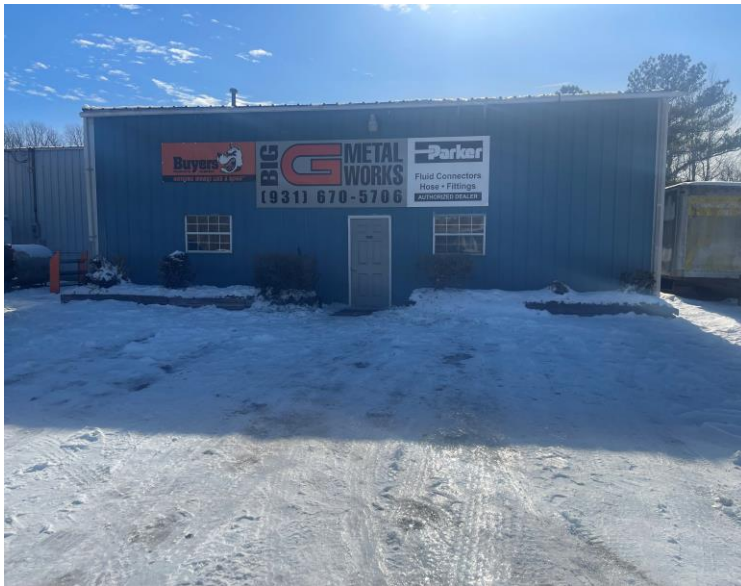
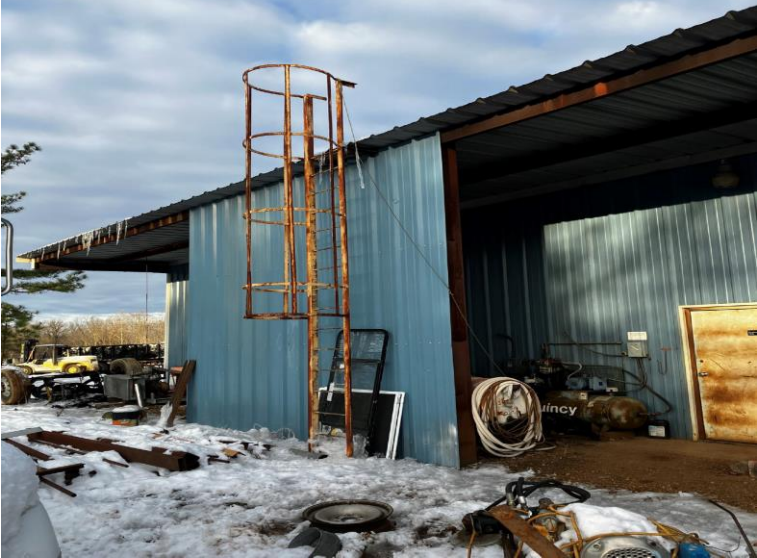
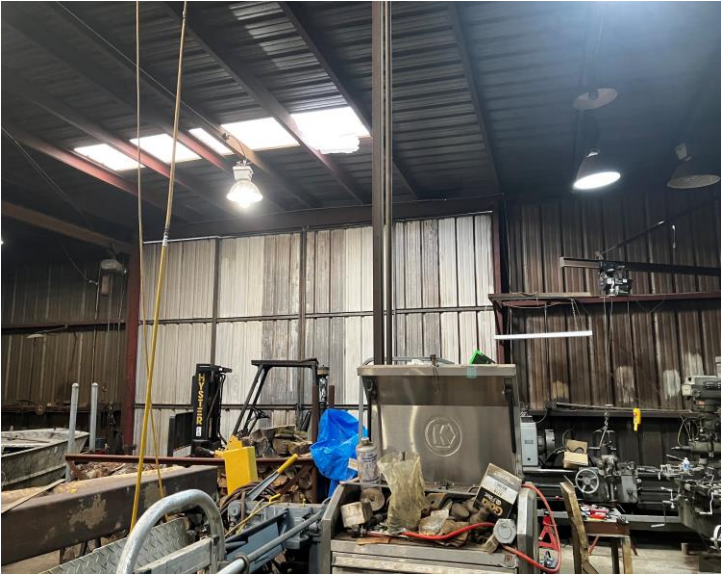
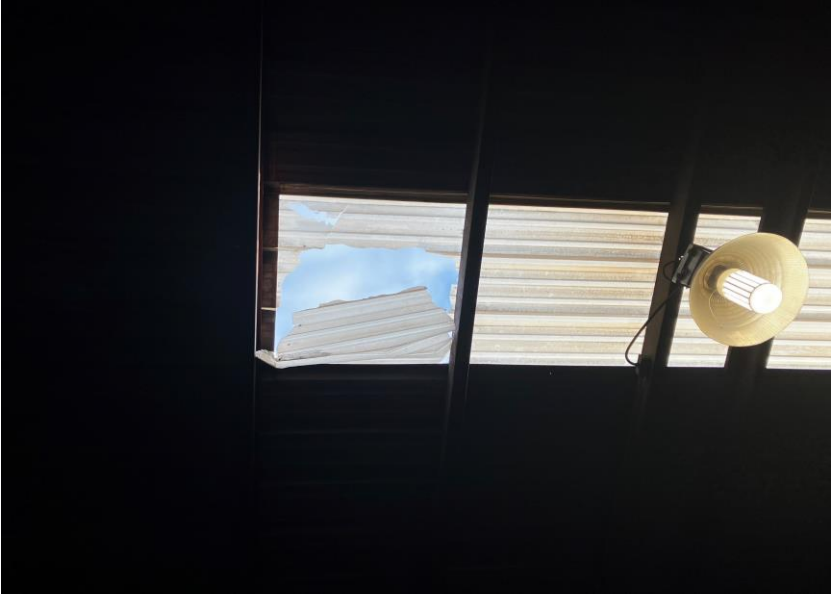
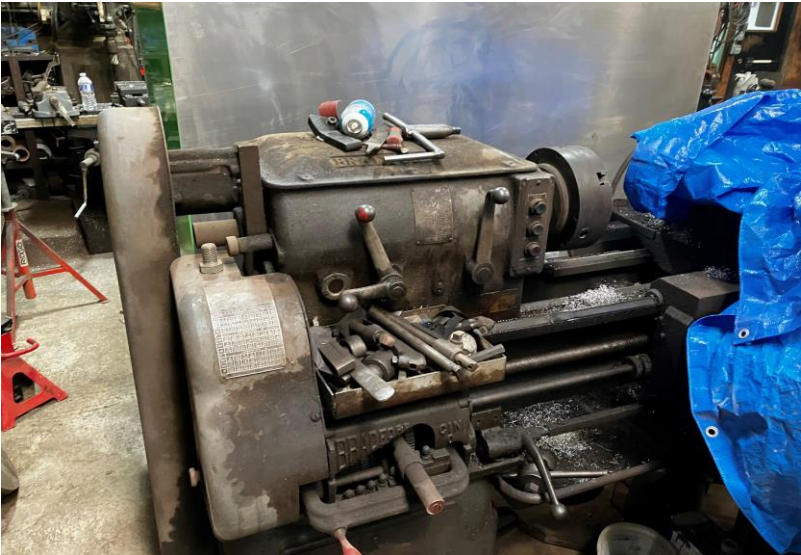
It was established that the victim fell through a skylight on the roof without utilizing any fall protection measures while removing snow from the 16-foot-high roof. The company owner verified the lack of fall protection harnesses or other fall protection equipment on-site. Additionally, the owner confirmed the lack of individuals trained to provide first aid, and employees had not undergone safety training related to hazard recognition.

In that, employees worked without fall protection on a flat roof 16 feet high, resulting in one employee falling through a skylight and receiving fatal injuries; the skylight was not rated to support personnel, and employees wore no fall protection.
